SAFETY RECALL

SR22-310

DATE: August 2022 SECTION: 18 CHASSIS
SUBJECT: USSC REAR BENCH SEAT BOLT MISSING

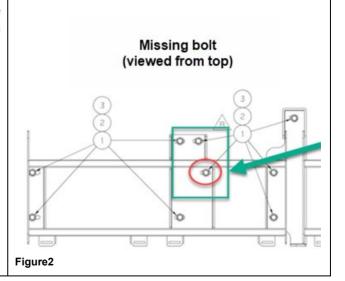
2. Locate the slot with a missing bolt in the rear seat base structure (red circle in Figure2).
