SAFETY RECALL

SR23-07

DATE :	April 2023	SECTION :	06 ELECTRICAL
SUBJECT:	Hazard Warning Lights Synchronization

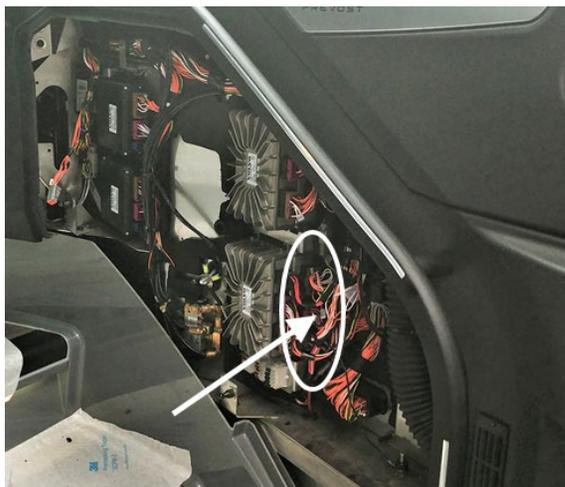
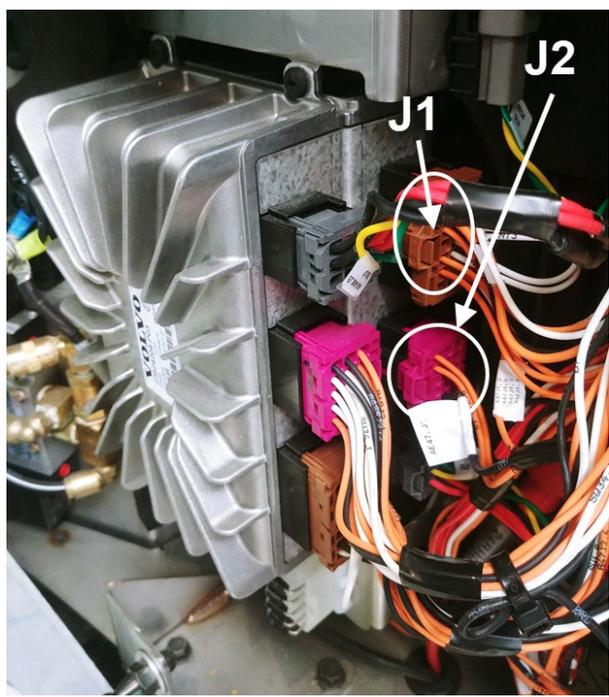
2. Locate the faulty connection.

- Locate the **A47** I/OB module in the compartment as shown.
- On the side of the module, locate the **J1** and **J2** connectors.
