# PREVOST

## WARRANTY BULLETIN

**WB23-11**

DATE :	April 2023	SECTION :	06 ELECTRICAL
EXPIRATION:	April 2025		
SUBJECT :	<b>HEADLIGHTS POWER SUPPLY</b>

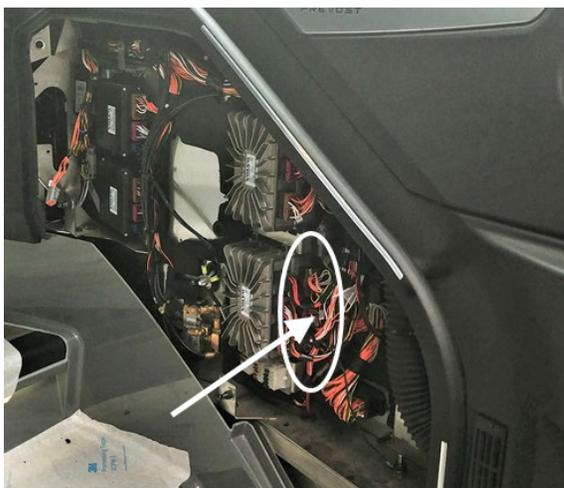
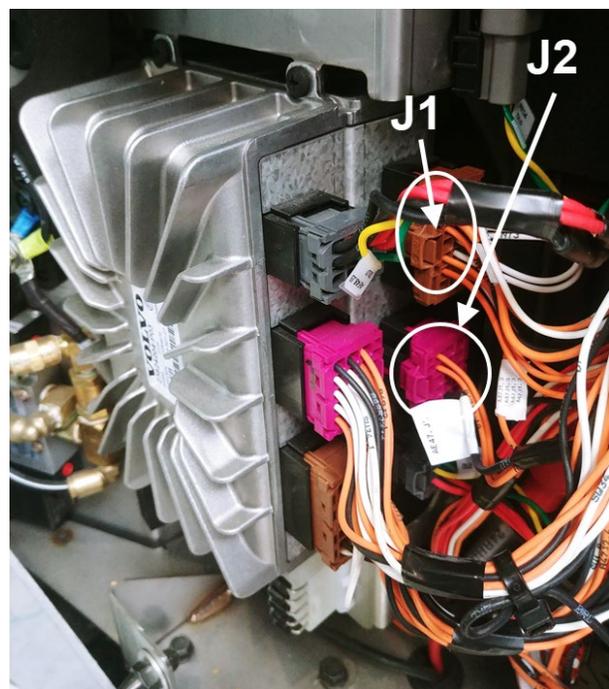
2. Locate the faulty connection.

The vehicles affected by this bulletin require an update of the multiplex program (06100191.P01 for H3-45 and 06100192.P01 for H3-45 VIP) due to an intermittent power supply problem affecting the front left headlight in high beam position.

- Locate the **A47** I/OB module in the compartment as shown.
- On the side of the module, locate the **J1** and **J2** connectors.
