PREVOST

SAFETY RECALL

SR23-304

DATE :	June 2023	SECTION :	18 BODY
SUBJECT:	Missing Weld on Passenger Flip-Up Seat

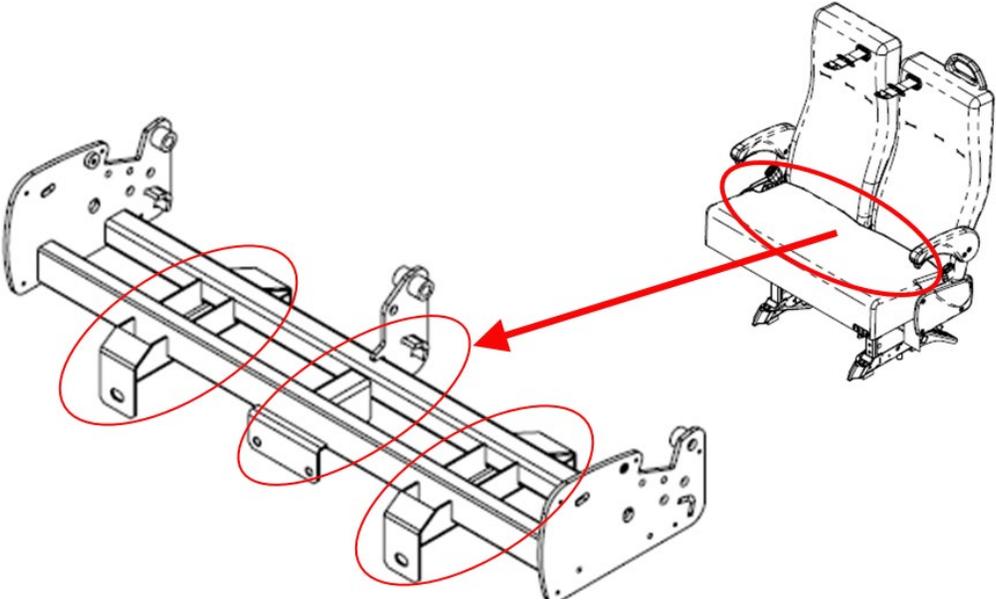
FLIP-UP SEAT FRAME

On the vehicles affected by this recall, some of the foldable passenger seat frames may have been improperly welded.

Therefore, all vehicles must have their folding seats inspected and their frames replaced as necessary following the inspection procedure provided below.

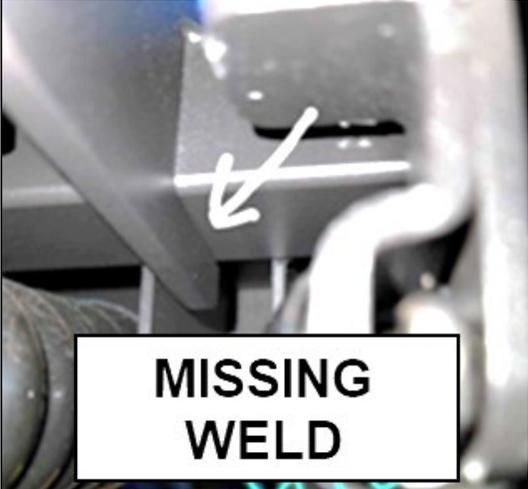
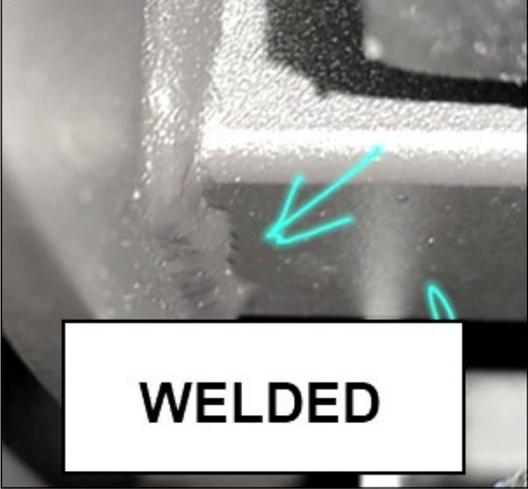
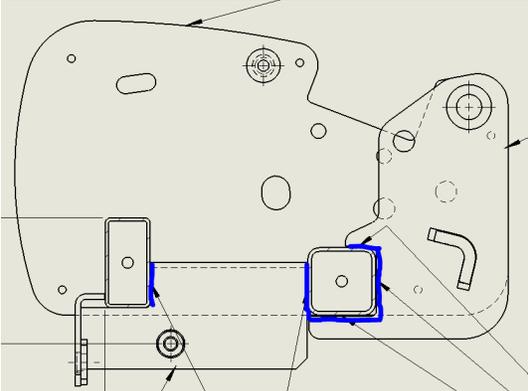
- 1. The tubes, brackets, and center pivot are to be welded as shown below in blue. The weld will be on both sides of the recline bracket and center pivot.

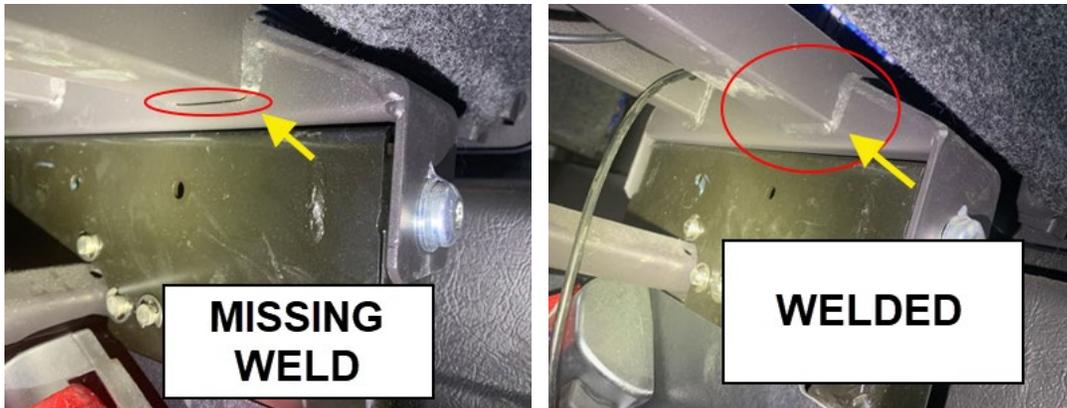
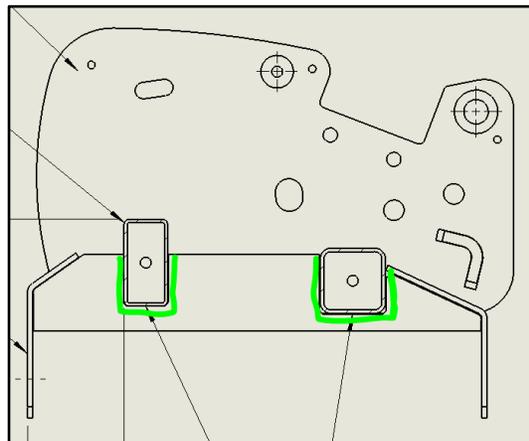
2. The tubes and brackets are to be welded as shown below in green. The weld will be on both sides of the pedestal brackets.
