**SAFETY
RECALL**

SR23-310A

DATE :	August 2023	SECTION :	18 BODY
SUBJECT:	SEAT RECLINE MECHANISM PIVOT BOLTS

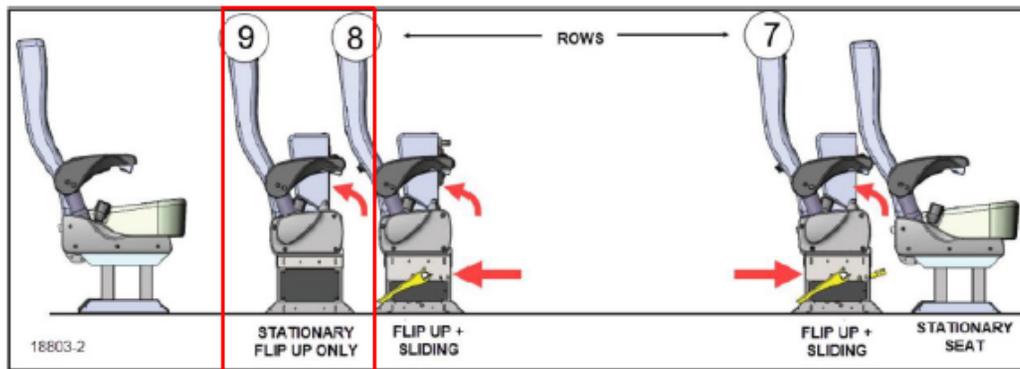
the bolt securing the passenger seat recline mechanism could loosen and disengage. In this condition, the seat's reclining function is inoperative (inability to lock the seatback in the desired angle), and the seatback can move freely within its adjusting limits. It is to be noted that the concerned seats are equipped with occupant seat belts integrated in the seat back.

Only the stationary flip up seat (see seat #9) are concerned by this issue (distinct recline mechanism design).

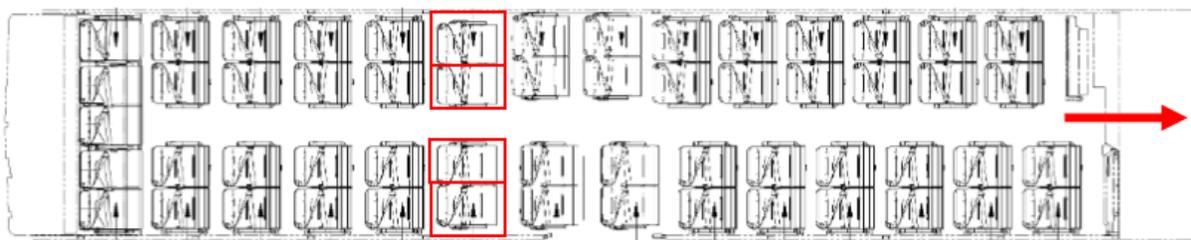
There are 4 potentially defective seats in each vehicle (stationary flip up seats – see seat #9 above).
Each seatback is secured with 1 bolt => 4 potentially concerned bolts per vehicle.

USSC SOLUTION : Add high-strength threadlocker (red) to flip-up pivot bolts.

- Remove the trim panel.
- Remove the pivot bolt.
- Add a good quality, high-strength thread-locking adhesive to the bolt threads.
- Reinstall the pivot bolt (tighten firmly).
- Reinstall the trim panel.
- Repeat for all seat bolts concerned.
