PREVOST

WARRANTY BULLETIN

WB23-24A

DATE:	November 2023	SECTION:	18 BODY
EXPIRATION:	November 2025		
SUBJECT:	SLIDING WINDOW SENSORS MISSING

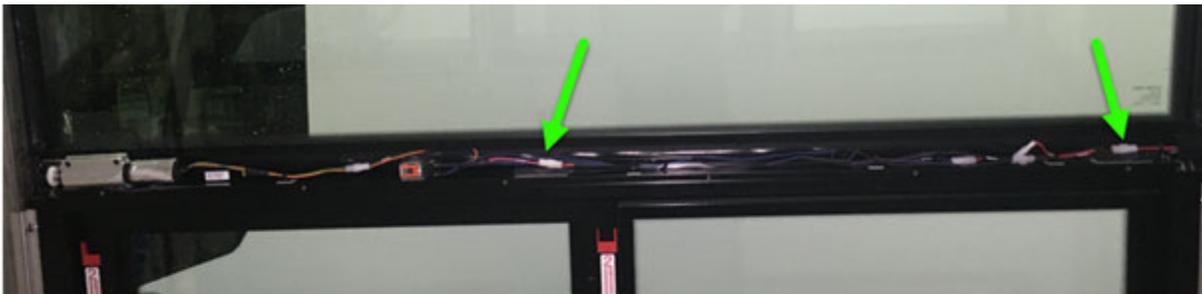
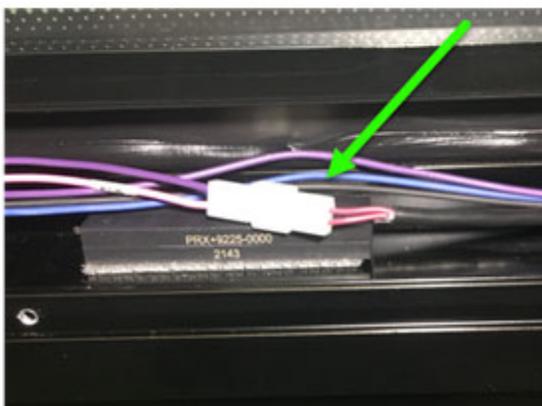
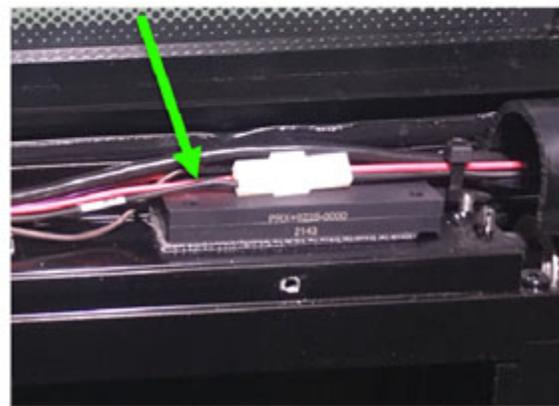
3. Validate if there are 2 sensors. If sensors are present.

- If yes reinstall header cover. Validate, when windows are open, the telltale of window ajar light up.
- If no, go to the next step.

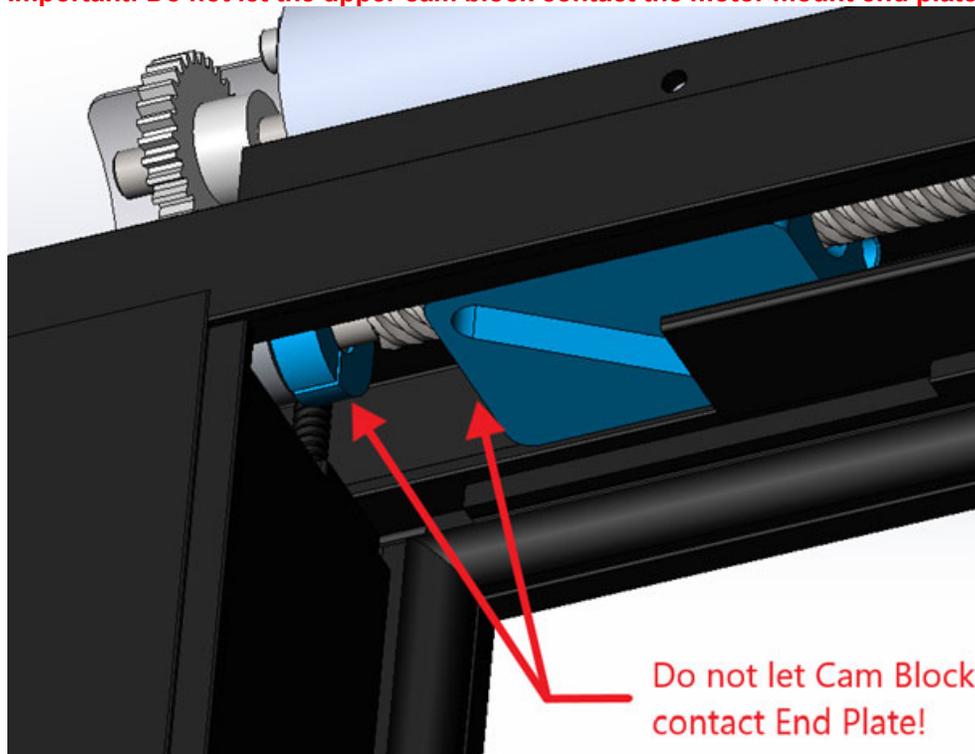
Important: Do not let the upper cam block contact the motor mount end plate.

2. Function the window fully open.
 - a. Make sure it stops when fully open (about 1–2 inches from the edge of the interior of the frame).
3. Place and hold the left sensor a couple inches to the right of the mark made by Arow (scratched line on top of the frame). Unlike the right sensor, this sensor will sit against the exterior panel of the window as shown instead of lying flat on the frame.
 - a. While functioning the window closed, let the slider window trip the sensor (the window will not be fully closed).
 - b. Slide sensor over to the left slowly while holding the closed button-down (the window will move as you slide the sensor over).

- c. Keep moving the sensor to the left until the sash is seated properly or until the sash pins are in the flat section of the cam blocks as shown in the second image below.
