**SAFETY  
RECALL**

**SR23-42**

DATE :	November 2023	SECTION :	06 ELECTRICAL
SUBJECT:	RETIGHTEN POWER RELAY R29 CABLE NUTS

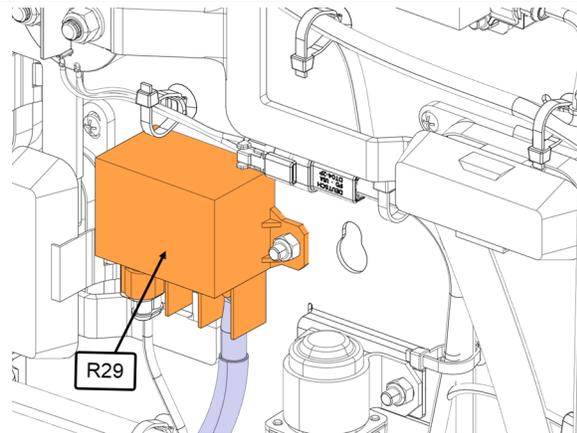
5. Locate the power relay **R29**.

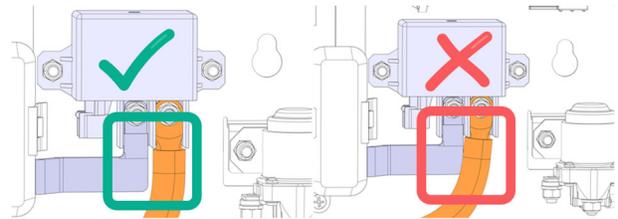
6. Loosen nuts before retightening.  
7. Before to apply the final torque, **verify the cable does not touch the bus bar.**

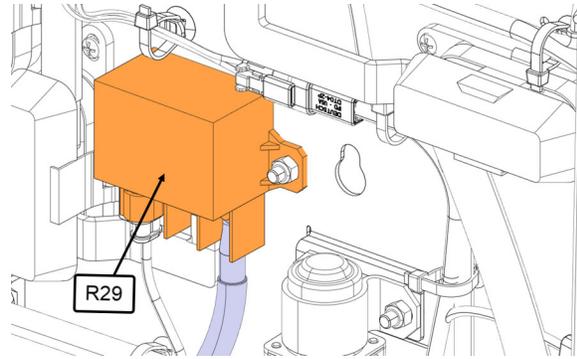
5. Locate the power relay **R29**.

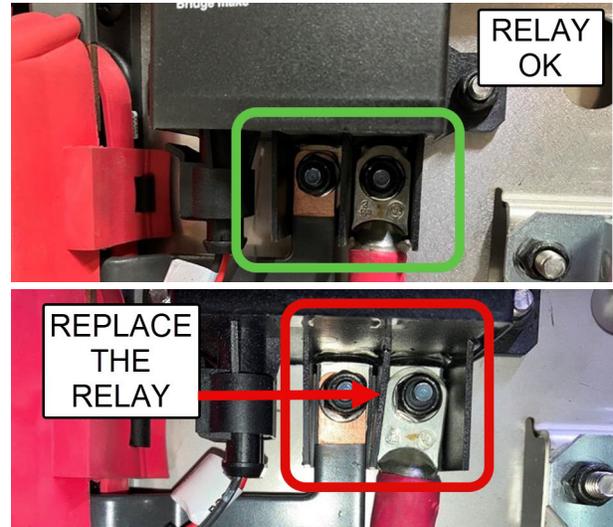
6. Inspect the power relay.

- If the relay connection divider is not damaged, go to the next step.
- If the relay connection divider is damaged see relay replacement section.
- If you do not have a new relay on hand, continue the procedure to ensure the quality of the assembly.

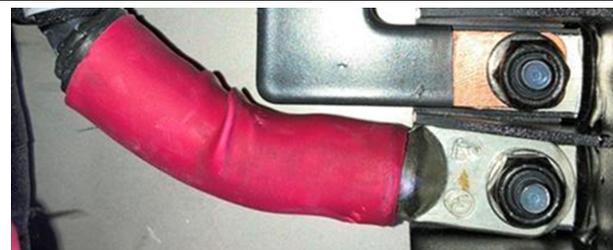
7. Inspect cable shrink tubing.

If shrink tubing of the cable is damaged, replace it with a new shrink tubing 561755.

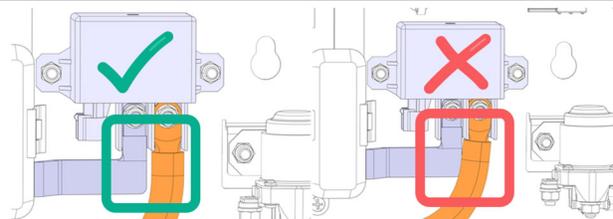
8. Loosen nuts before retightening.

9. Before to apply the final torque, **verify the cable does not touch the bus bar.**

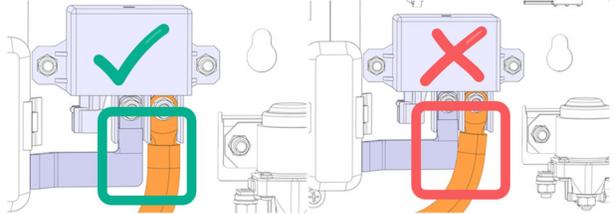
12. Before to apply the final torque, **verify the cable does not touch the bus bar.**
