PREVOST

WARRANTY BULLETIN

WB23-28A

DATE :	November 2023	SECTION :	18 BODY
EXPIRATION:	November 2025		
SUBJECT :	BAGGAGE DOOR SEAL REPLACEMENT

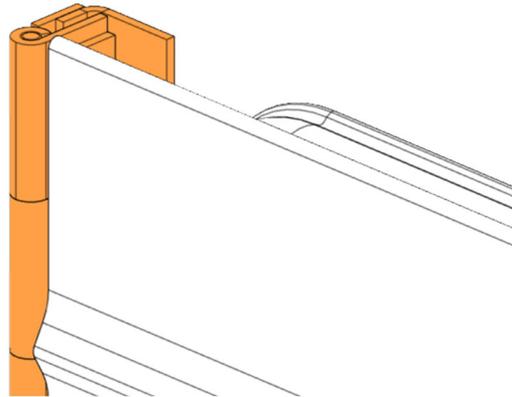
Do not replace the gasket on doors with piano hinge.
