PREVOST

WARRANTY BULLETIN

WB23-34

DATE:	December 2023	SECTION:	06 ELECTRICAL
EXPIRATION:	December 2025		
SUBJECT:	ENGINE ACCESSORIES HARNESS MODIFICATION

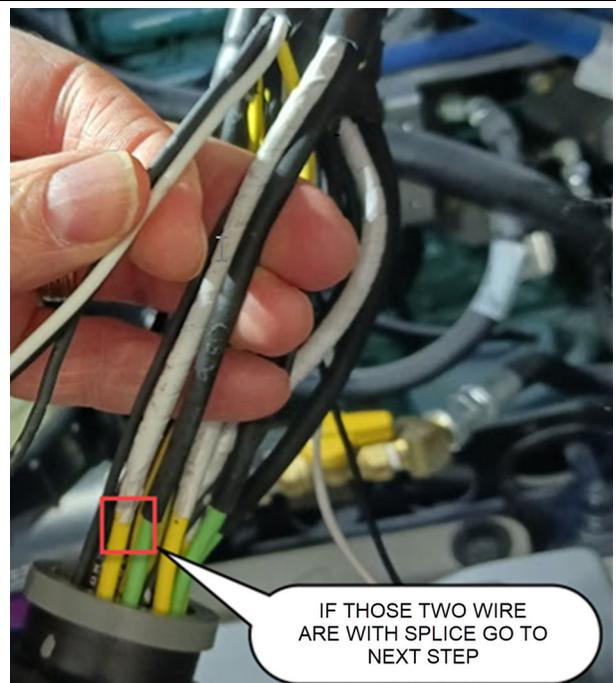
4. Remove one foot of the loom from the connector B99.
5. Verify if you have wires with a splice see the picture.
 - If yes, go to the next step.
 - If no, reinstall the loom and secure the harness to complete the procedure.
