PREVOST

WARRANTY BULLETIN

WB23-37

DATE:	December 2023	SECTION:	06 ELECTRICAL
EXPIRATION:	December 2025		
SUBJECT:	WIPER MOTOR HARNESS MODIFICATION

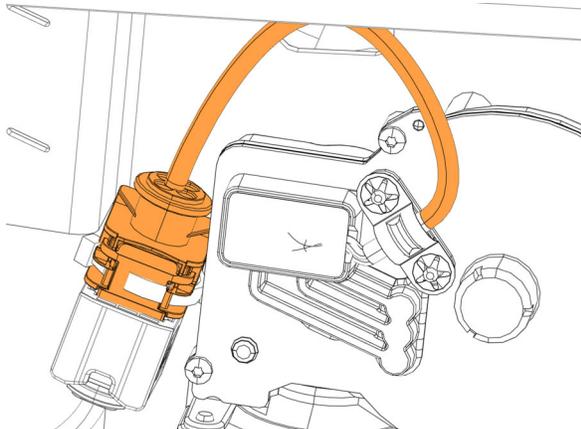
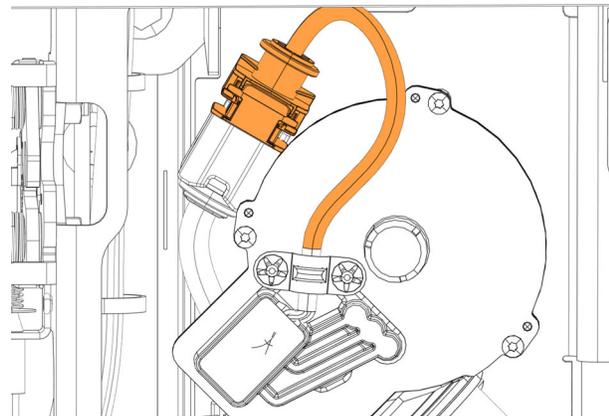
On the vehicles affected by this bulletin, the wiper motor harness needs a modification to avoid connector terminals corrosion.

4. Locate the connector of the wiper motor.

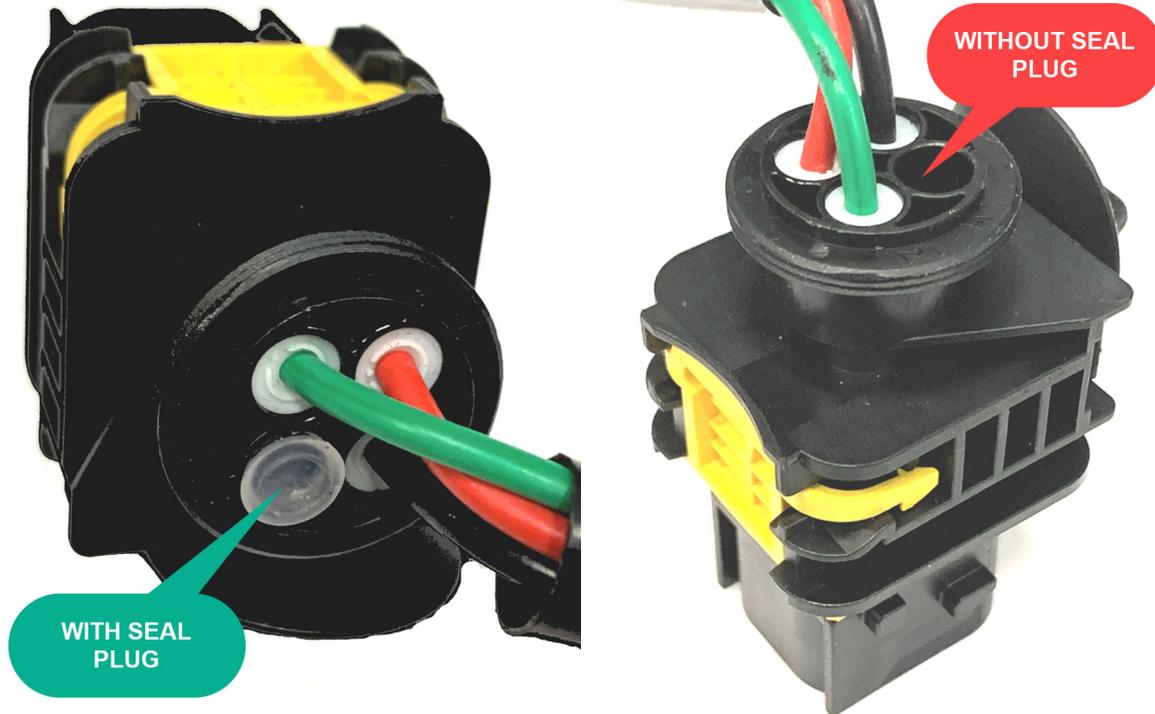
5. Verify if the connector has a plug into the empty cavity.
- If no, go to the next step.
 - If yes, the procedure is complete.
