PREVOST

WARRANTY BULLETIN

WB23-45

DATE :	January 2024	SECTION :	06 ELECTRICAL
EXPIRATION:	January 2026		
SUBJECT :	ELECTRONIC GROUND STUD – CABLE 00 AND 00FR UNPROPERLY CONNECTED

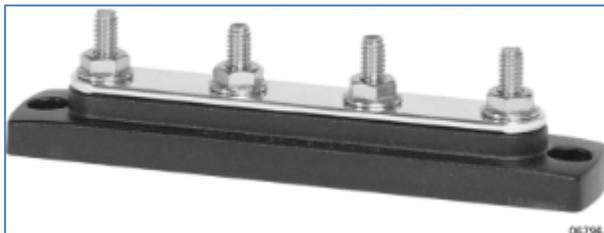
FIGURE 2

1. Open the main power compartment door. Locate the electronic ground terminal block.

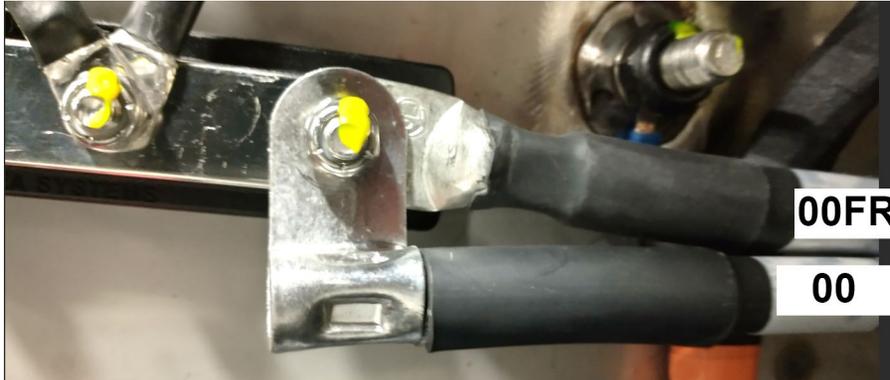
Cable 00 flag terminal has a 3/8" hole and the ground terminal block has a 1/4" stud. For this reason, the cable 00 flag terminal must be installed on the electronic ground terminal block first.

FIGURE 4: **INCORRECT** INSTALLATION - CABLE 00FR TERMINAL IS NOT PLACED OVER CABLE 00 FLAG TERMINAL

3. Remove both terminals from the terminal block stud.
4. Reinstall the terminals, placing cable 00 flag terminal fist, followed by cable 00FR terminal.
5. Fasten using a **new** NYRT nut p/n 5001251. Proper **torque** is 60 lbs-in.
6. Once tightened, apply Torque Seal mark.
7. Reset all open breakers to close the circuits.
8. Set the main electrical shut-off switch to the ON position.

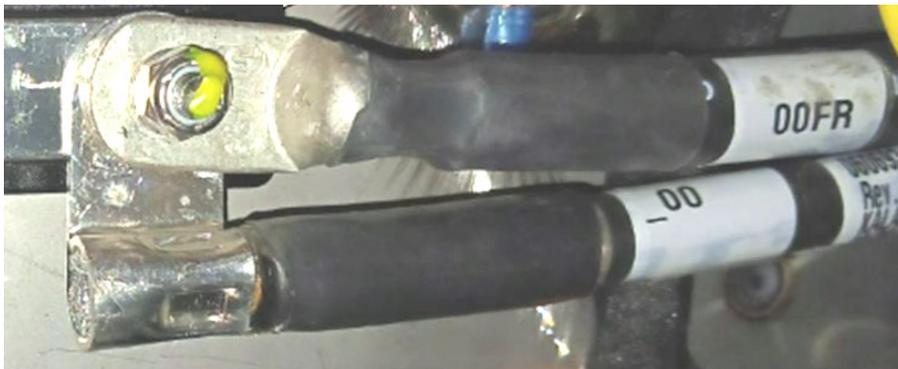
2. Check if the cable 00 flag terminal is secured in the proper order to the ground terminal block.
 - Cable 00 flag terminal must be installed first.
 - Cable 00FR terminal must be placed over cable 00 flag terminal.

Figure 5: **CORRECT** INSTALLATION
