PREVOST

**SAFETY
RECALL**

SR23-43

DATE :	January 2024	SECTION :	23 ACCESSORIES
SUBJECT:	PREVOST DRIVER ASSIST – VERIFICATION OF ACB RADAR SENSOR FRONT BUMPER TRIM

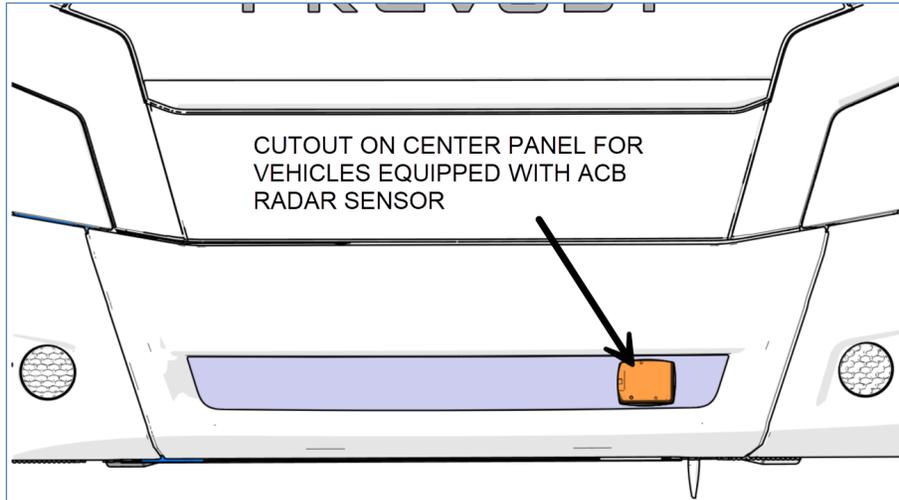
Figure 1: VEHICLE EQUIPPED WITH ACB RADAR SENSOR

1. Vehicles equipped with the ACB radar sensor should have a cutout on the front bumper trim as seen on the image below.

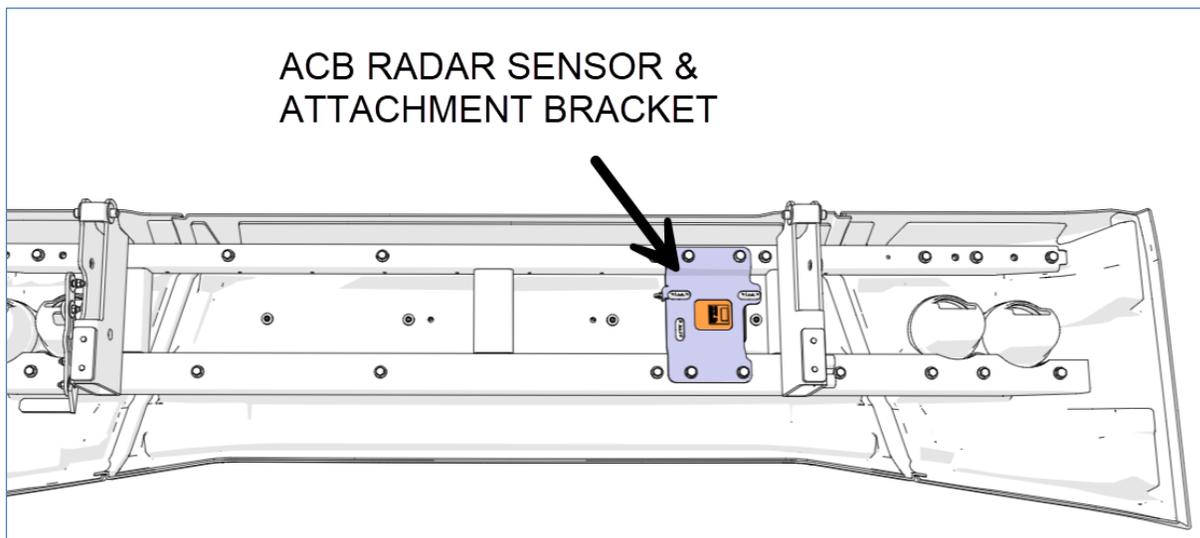
Figure 2: VEHICLE EQUIPPED WITH ACB RADAR SENSOR

2. Open the reclining bumper. Confirm your vehicle is equipped with the ACB radar sensor.
