PREVOST

WARRANTY BULLETIN

WB23-29

DATE :	January 2024	SECTION :	06 ELECTRICAL
EXPIRATION:	January 2026		
SUBJECT:	CABLES AND SOFTWARE MODIFICATION FOR THE UNLATCH CONTROL

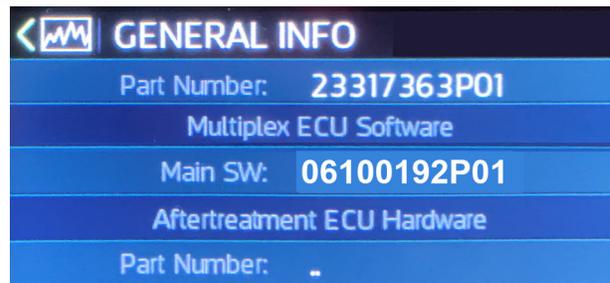
4. Scroll to **Multiplex ECU software**. The DID show the multiplex software number and the actual revision number just after the letter "P".
