Warranty Bulletin

WB23-88

T-PIPE REPLACEMENT 9700 (B13R)

On the vehicles affected by this bulletin, possibility of coolant leaking through the T-fitting.

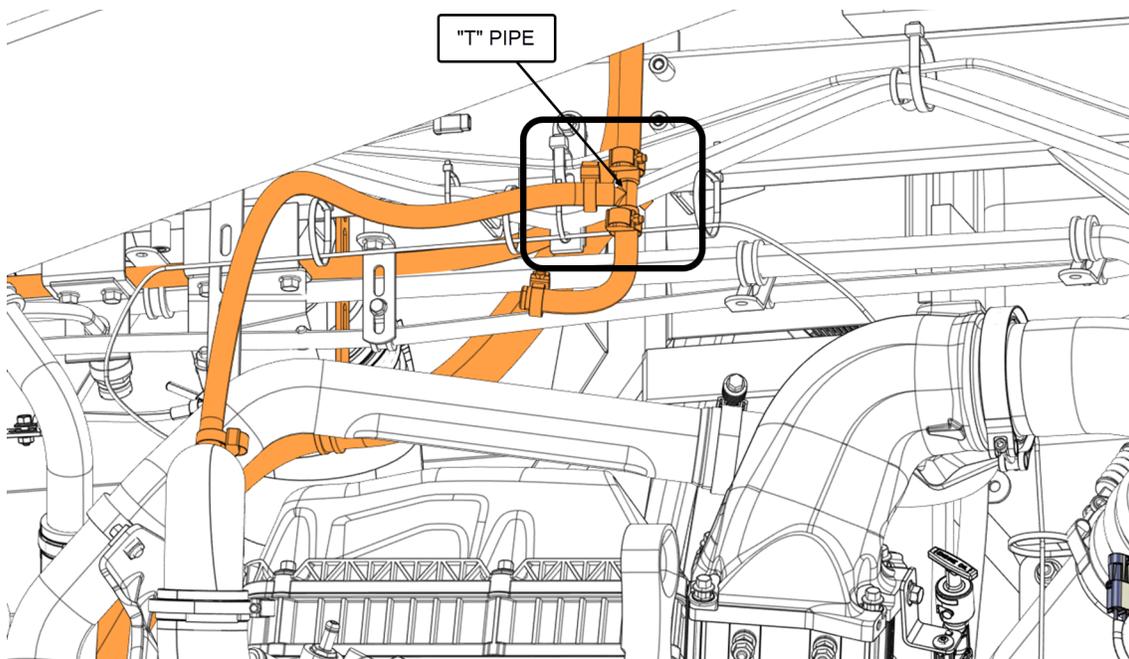
4. Locate the first "T" pipe below the coolant reservoir.

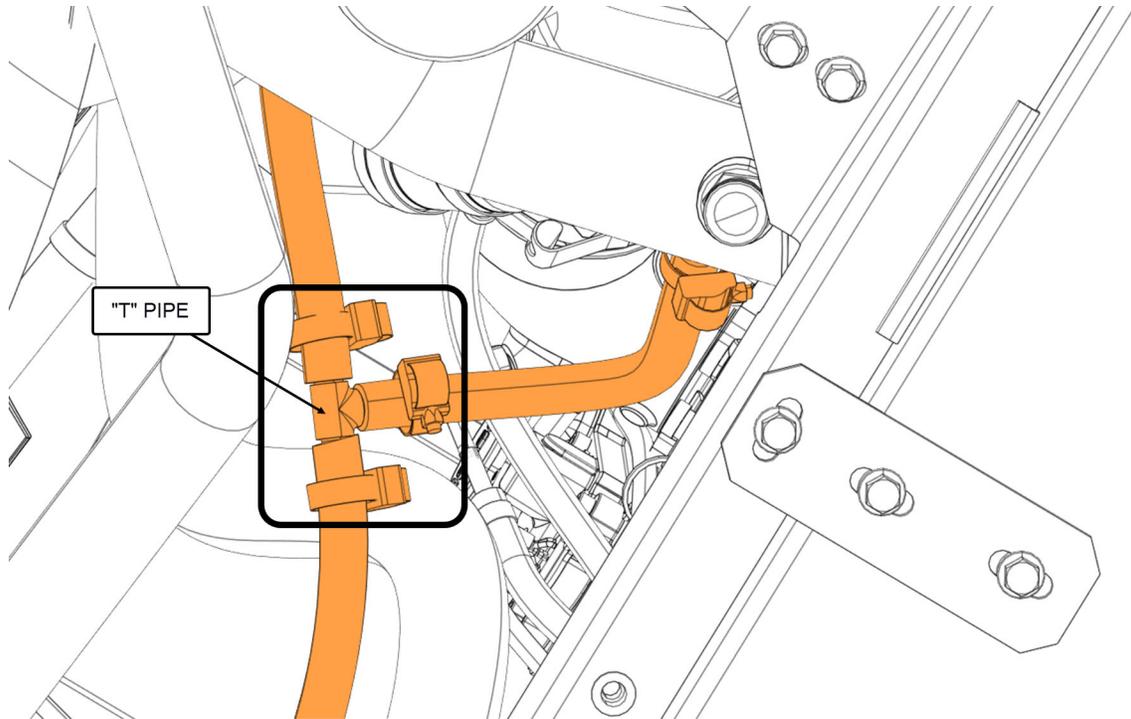
7. Locate second "T" pipe between radiator and engine block on coolant hose of the DEF tank (near the coolant extract fitting).
