WARRANTY BULLETIN

WB15-44

DATE :	SEPTEMBER 2015	SECTION:	13 - Wheels, Hubs Tire	
EXPIRATION:	SEPTEMBER 2017			
SUBJECT :	WHEEL LUG NUTS TIGHTENING INSPECTION

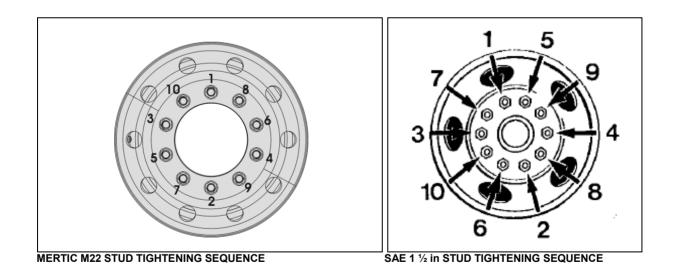
On the vehicles affected by this bulletin, the equipment used to tighten the wheel lugs in a visit to one of our Service Center between November 2014 and June 2015, was found to be out of specification, possibly delivering a torque value inferior to the specified 450 to 500 ft-lb (610 to 680 Nm). Please verify and correct as necessary the wheel lug torque on the concerned vehicles, or bring the vehicle at a Prevost Service Center for verification at your earliest convenience.

1. Raise the vehicle by its jacking points.

2. With a properly calibrated torque wrench and appropriately sized open box socket, check the torque value of *the lug nuts on all vehicle wheels* following the sequence shown above. Correct as necessary.

Correct torque value for all wheels: 450 to 500 ft-lb (610 to 680 Nm).

Tightening should not be done immediately after prolonged braking or when wheel ends are hot.
