PREVOST

MAINTENANCE Mi11-16 **INFORMATION**

SUBJECT: ADDITION OF A RESISTOR ON EVAPORATOR

COMPARTMENT FAN SPEED CONTROL CIRCUIT WHEN REPLACING A53 OR A54

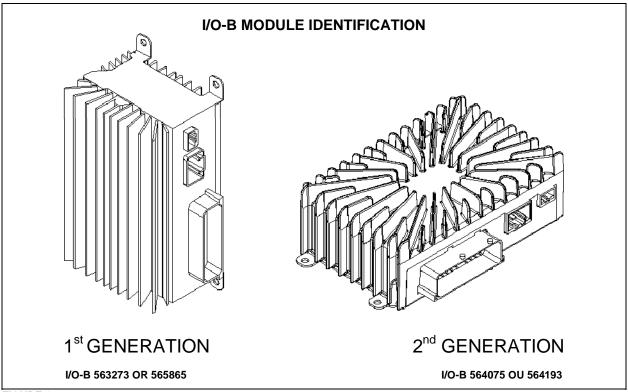
FIGURE 1

This procedure is needed only when proceeding to the replacement of <u>first generation</u> A53 (H3-41, H3-45, X3-45) or A54 (XLII MTH, H3 VIP) multiplex module with <u>second generation</u> module (see figure 1 for module generation identification). In this case, addition of a 3650Ω resistor parallel to circuit 131 (evaporator fan 2^{nd} speed) is required. Without the addition of this resistor, evaporator fan might not run in second speed (fast).

Second generation module speed control signal voltage is higher than with first generation module (5 volts rather than 3.8 volts). 5 volts signal is too high to permit engagement of evaporator drive motor in 2nd speed (fast).
