PREVOST

**MAINTENANCE
INFORMATION**

Mi98-06

DATE: March 1998	SECTION: 22
SUBJECT: REPLACEMENT OF PLASTIC BRACKETS

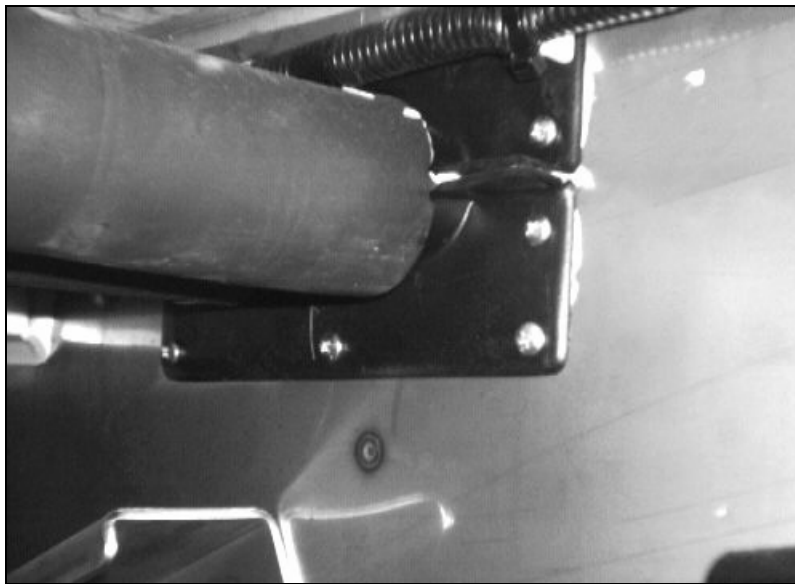
FIGURE 2: PLASTIC BRACKETS (TYPICAL INSTALLATION)

On the above-mentioned vehicles, the plastic brackets located in rear baggage compartment supporting the high pressure tubes may melt due to extreme heat which may cause leaks on high pressure side of A/C system.

1. In rear baggage compartment (refer to fig. 1), cut locking ties and move cables out of the way if necessary.
2. Take out screws from plastic brackets then remove brackets (refer to fig. 2). Set screws aside.
3. Remove Sikaflex 221 sealant and clean surface.
4. Apply Sikaflex 221 sealant onto the wall then fix stainless steel brackets (Prévost #453145) using screws.
5. Secure cables using locking ties.
