# PREVOST

## WARRANTY BULLETIN

### WB23-21

DATE :	October 2023	SECTION :	22 HVAC
EXPIRATION:	October 2025		
SUBJECT :	<b>DEFROSTER FLAP ADJUSTMENT</b>

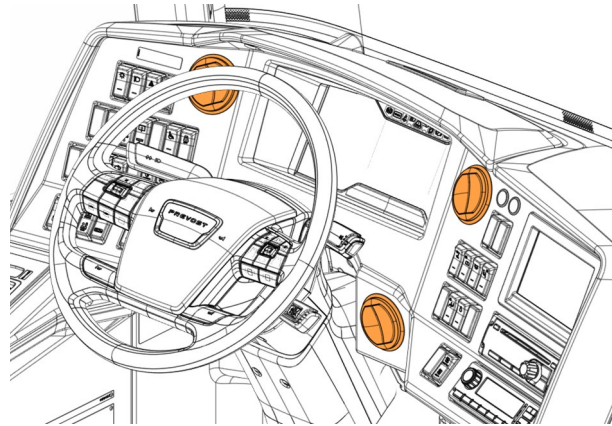
3. Validate if you have full air output from dash vents.

If yes, go to the next step.

If not, the procedure is complete.
