SAFETY RECALL

Sr12-19

SUBJECT: REPLACEMENT OF STEERING GEARBOX

MOUNTING BOLTS

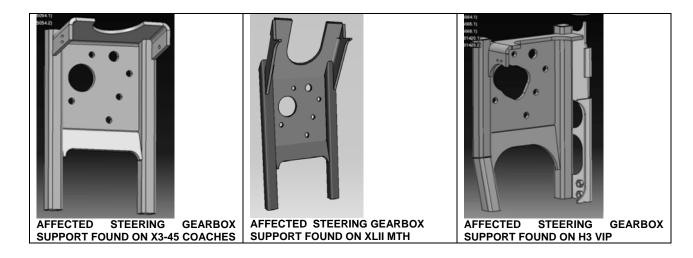
The steering gearbox mounting bolts found on the involved vehicles are too long to be used with the steering gearbox support design installed on the involved vehicles.

Too long bolts will reach the bottom of the blind holes found on the steering gearbox before a sufficient clamping force is created to maintain the steering gearbox properly fastened on its support. Bolts may be insufficiently torqued.

With the passing of time, the steering gearbox bolts may start to loosen, leading to reduced steering function, thus increasing the risk of a crash.

In order to maintain steering gearbox in proper position, replace mounting bolts one at a time.

- 1. Unscrew and discard a first steering gearbox mounting bolt and washer.
- 2. Replace that bolt and washer using bolt #5001442 and a flat washer #611044. Apply blue Loctite 243 on bolt threads and tighten to a torque of **385 lbf-ft**.
- 3. Repeat the previous steps for the second bolt and so on up to the fifth bolt.
- 4. Finally, apply an anti-corrosion compound on bolts head and washers.
