**PREVOST**

## SAFETY RECALL

**SR13-01**

DATE : JANUARY 2013	SECTION : 10-FRONT AXLE
SUBJECT :	RADIUS ROD SUPPORT

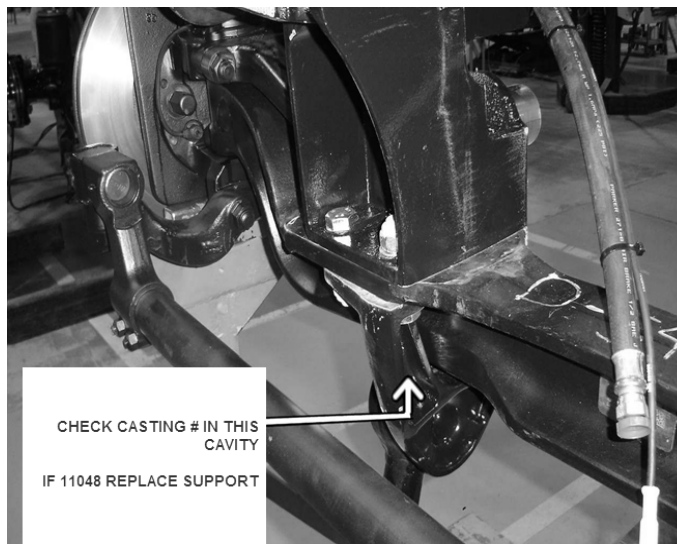
1. On front I-Beam axle, left hand side (road side). Check casting number in cavity of radius rod support 110739.

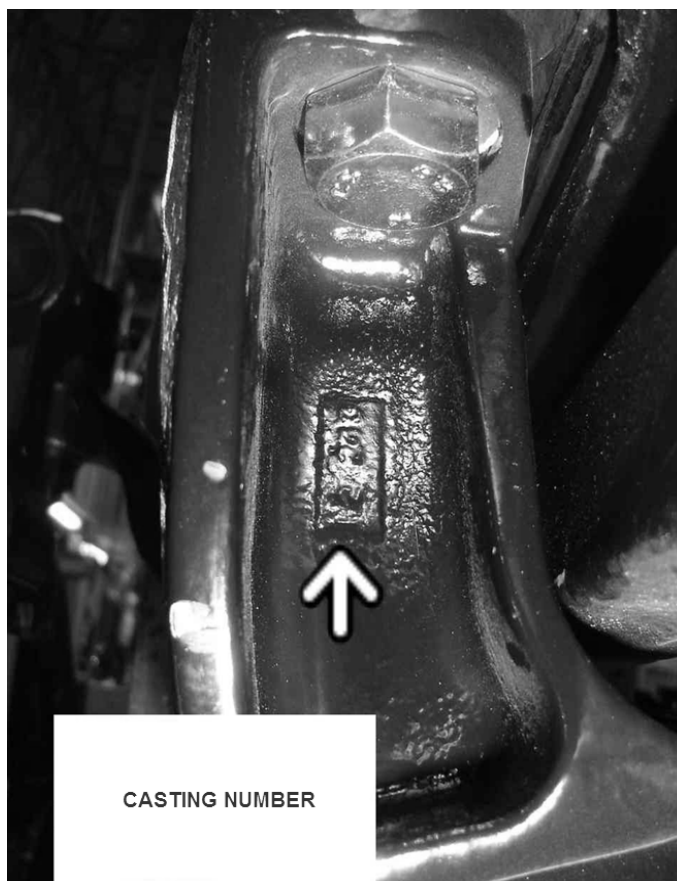
2. If casting number in cavity is **11048**, part must be replaced.
