PREVOST

**SAFETY
RECALL**

SR13-07B

DATE : APRIL 2013	SECTION : 01-ENGINE
SUBJECT : MODIFICATION OF ENGINE SPEED PARAMETERS FOR THE LIMP HOME MODE – VOLVO D13 ENGINE ECU SOFTWARE UPDATE

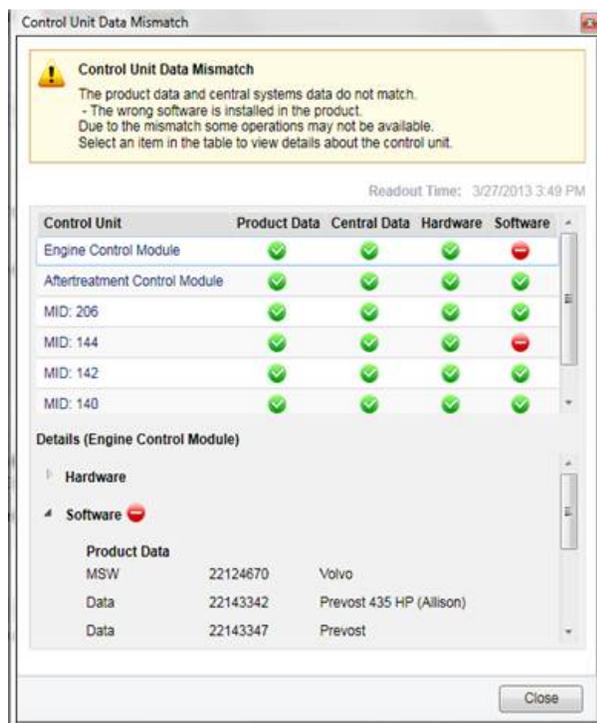
1. Update the engine ECU software (MID128) with the latest program version available.
2. **IMPORTANT.** Using PTT, check if there are other electronic control modules requiring a software update. Modules requiring a software update will be identified with a dash in a red dot in the table as shown below.
