PREVOST

**WARRANTY
BULLETIN**

Wb00-12

| SUBJECT : WIRE 136A SPLICE WAT ERTIGHTNESS | |

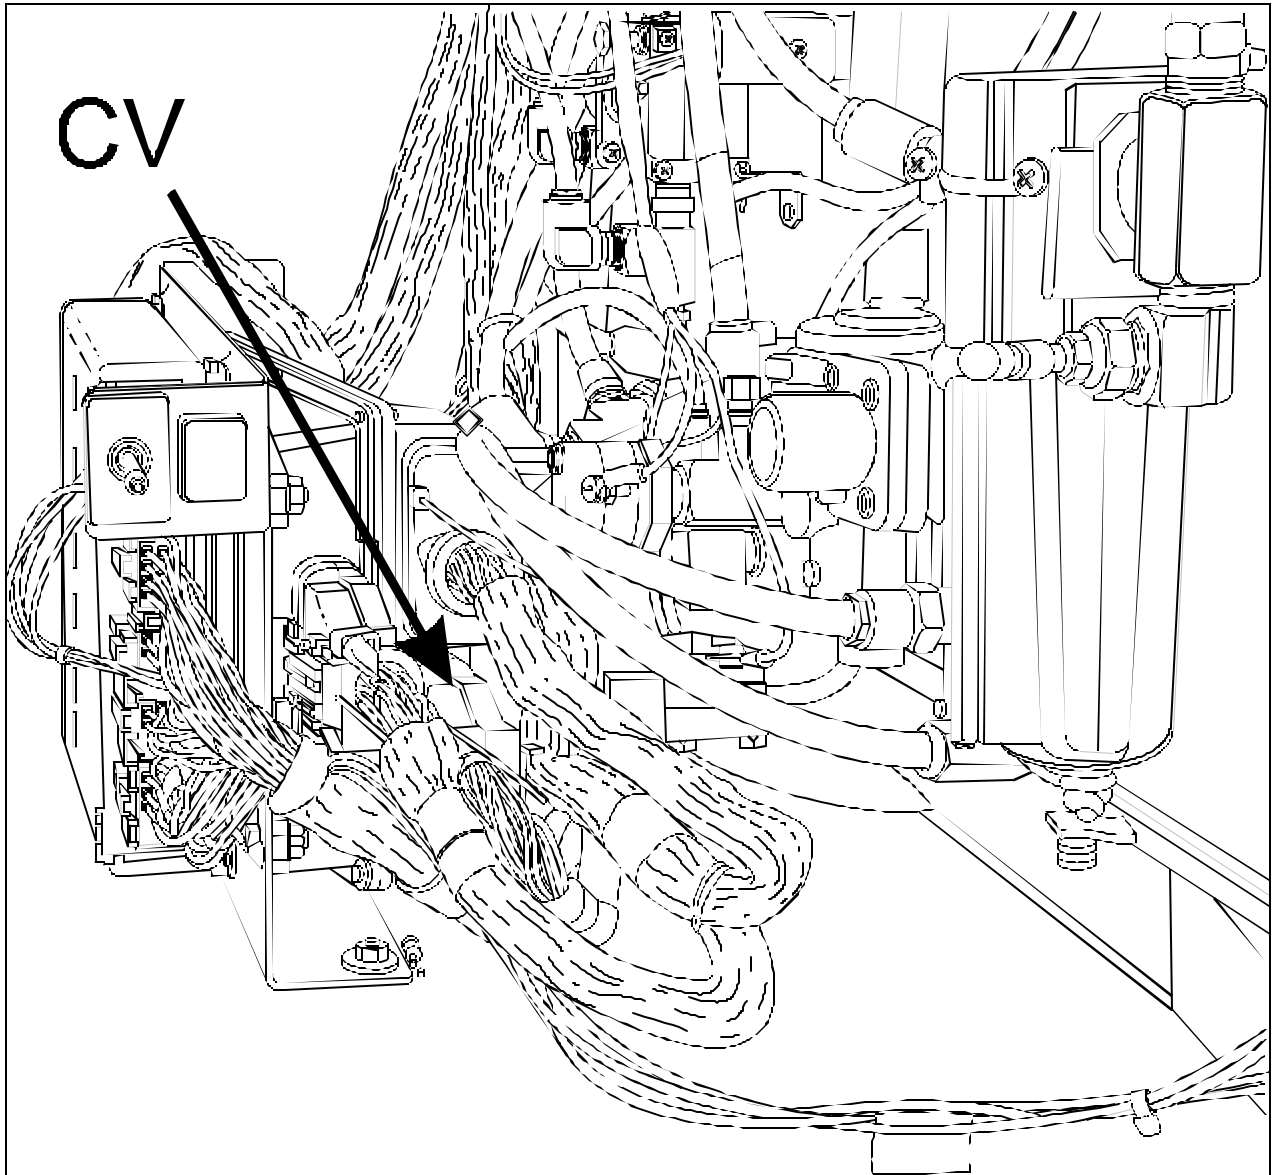
FIGURE 1: FRONT SERVICE COMPARTMENT (TYPICAL)

- ? In the front service compartment, locate connector CV on the transmission ECU (see fig 1);
- ? Follow the cable up to the identification label, about 12 inches (300 mm) from the connector;

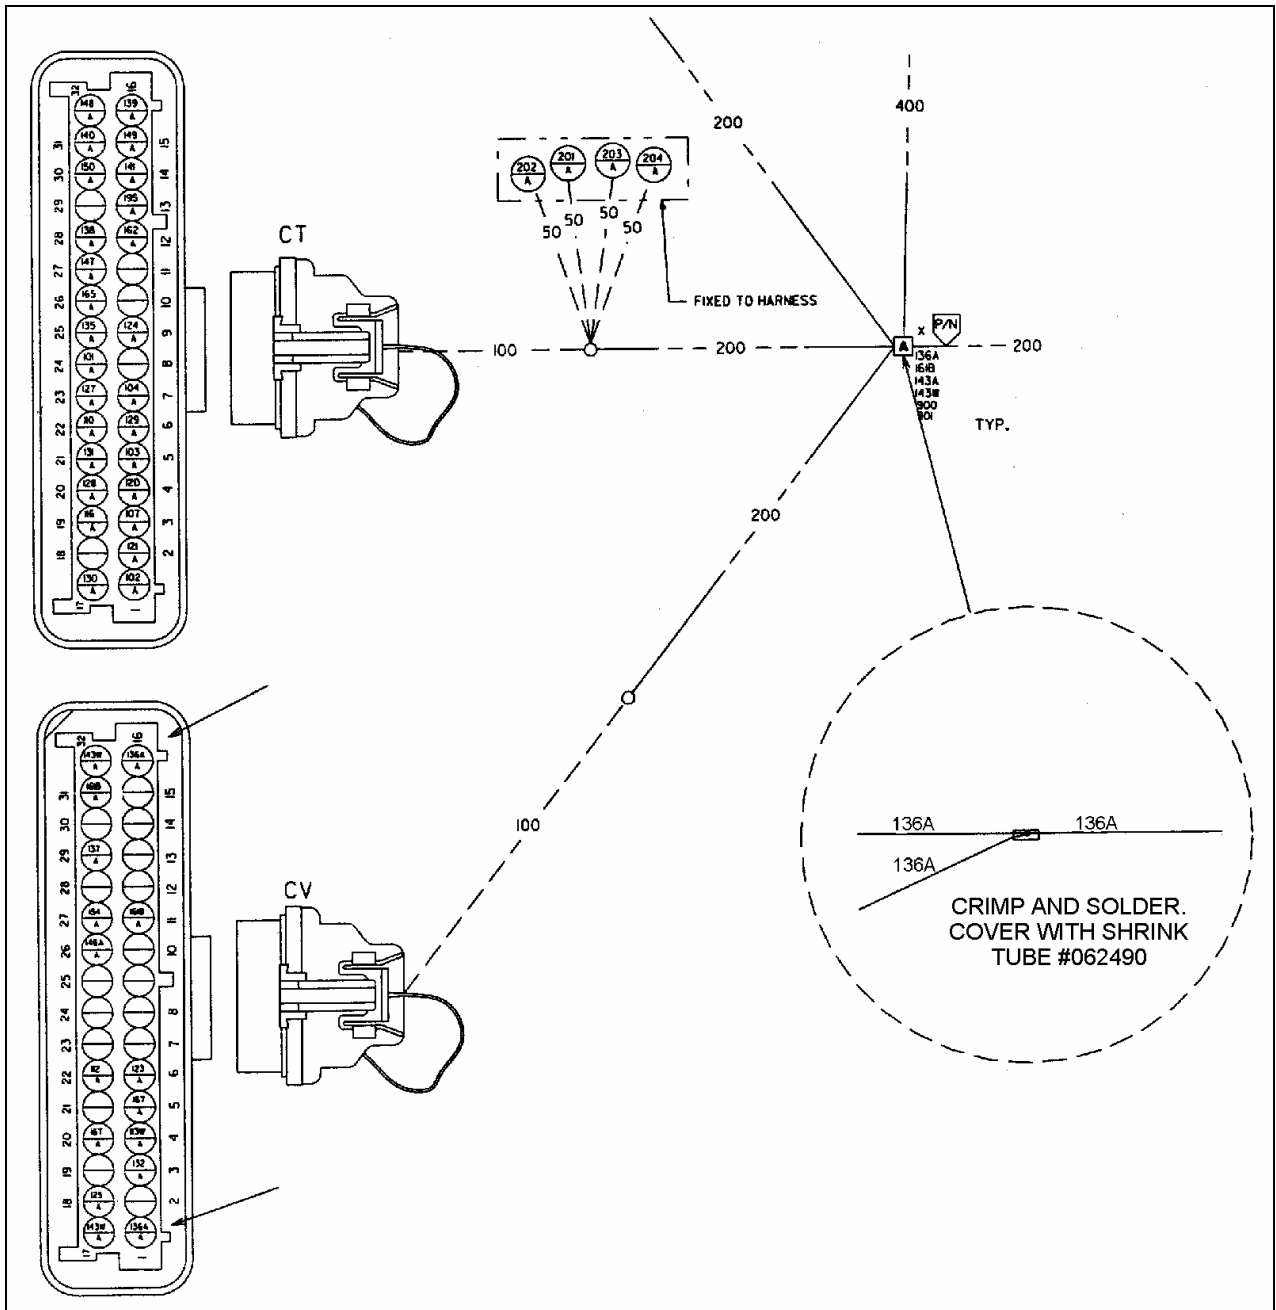
FIGURE 2: SCHEMATIC OF THE SPLICE IN WIRE 136A, CABLE #064660 OR #064655 (XL VEHICLES)

Wire 136A splices before connecting into CV connector to the World transmission ECU. This splice may corrode over time therefore blocking electrical current to the ECU. The following instructions will protect this connection against moisture and corrosion.

1. Practice an incision in the outer shield of the cable, about 12 inches (300 mm) from the connector (see fig. 2). Be careful not to damage the wires inside the cable;

2. Locate the splice, cut the wires at the splice;
 3. Insert the shrink tubing over the main wire and redo the splice by crimping then soldering the wires;

4. Slide the dual wall shrink tubing over the splice and heat to shrink;
 5. Put back the wires in the shield and close with electrical tape (#680319). Attach cable off the floor using cable ties.
