WARRANTY BULLETIN

Wb03-09

SUBJECT: REPLACEMENT OF BALL STUD NUTS ON

BAGGAGE COMPARTMENT DOOR CYLINDERS

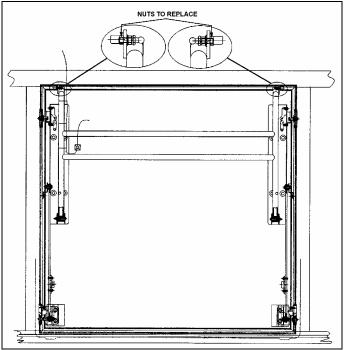
FIGURE 1

On the above-mentioned vehicles, the fixing mechanism for the baggage compartment door cylinders <u>may</u> be defective. Improper nuts have been used by mistake with the ball studs and therefore may not safely support he doors.

2. Replace the two nuts onto each baggage compartment door as per figure 1 and 2.
