PREVOST

**WARRANTY
 BULLETIN**

Wb03-23

DATE : NOVEMBER 2003	SECTION :	18 - Body
EXPIRATION: NOVEMBER 2005		
SUBJECT: VERIFICATION OF RADIATOR DOOR AND ENGINE COMPARTMENT CURB-SIDE DOOR LATCH MECHANISM

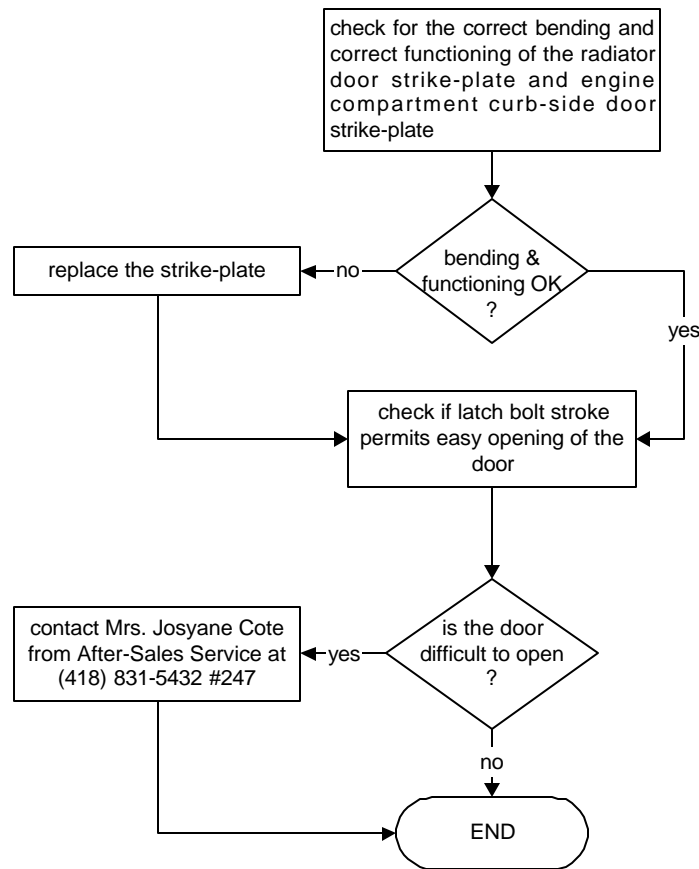
FIGURE 1: RADIATOR DOOR, INSIDE VIEW

On the above mentioned vehicles, there is a risk that the radiator door opens while the vehicle is traveling. This is due to a wrong bending of the strike-plate. It is necessary to check the strike-plate bending and if needed, to replace it.

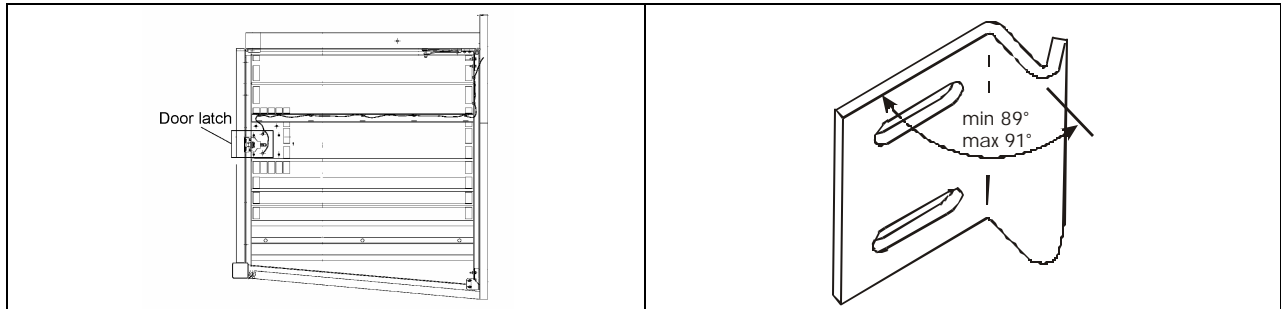
FIGURE 2: STRIKE-PLATE

1. Open the radiator. Check for the proper bending of the strike-plate (figure 2). The angle must be at $90^{\circ} \pm 1^{\circ}$. If the angle is different from that specification, replace the strike-plate. Do the same verification for the engine compartment curb-side door.

Note: Check that the door latch retains the door closed securely. Pull the door to open it without actuating the latch lever. If the door opens, the strike-plate has to be replaced.

Part No.	Description	Qty
287286	Strike-plate	1 or 2 as required

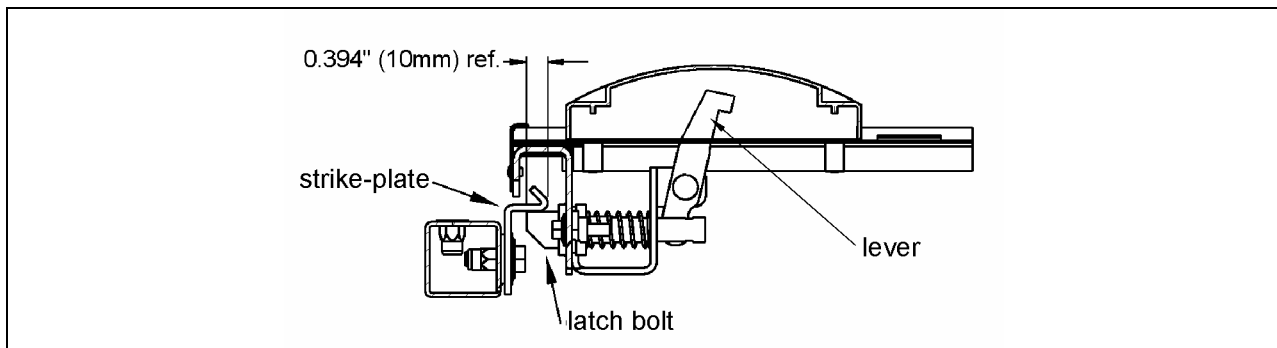
FIGURE 3: LATCH BOLT STROKE VERIFICATION. IDENTIFICATION OF COMPONENTS

2. With the radiator door closed, actuate the door latch lever to open it. Check if there is friction or obstruction between the latch bolt and the strike plate. If the door is difficult to open, it is necessary to replace the latch mechanism by a new one that allows a longer latch bolt stroke. To do so, contact Mrs. Josyane Cote from the after-sales service at (418) 831-5432#247.

Note : To maintain the door closed securely, the latch bolt must engage 0.394" (10mm) behind the strike-plate. The latch bolt must clear completely the strike-plate to permit easy opening of the door.
