PREVOST

WARRANTY BULLETIN

Wb04-04

DATE : APRIL 2004	SECTION : 01 - Engine
EXPIRATION: APRIL 2006	
SUBJECT : REPLACEMENT OF HOSES AND CLAMPS AND VERIFICATION OF MINIMUM CLEARANCE ON THE CHARGE AIR COOLER (CAC) SYSTEM

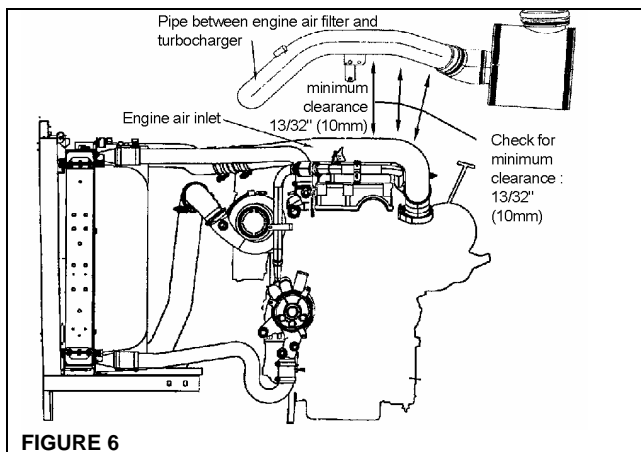
FIGURE 6

TABLE A – Minimum clearance				
COMPONENT 1		COMPONENT 2	MINIMUM CLEARANCE	FIGURE
Pipe between engine air filter and turbocharger	&	Engine air inlet pipe	13/32" (10mm)	6
	&	Engine air inlet pipe support	13/32" (10mm)	7
	&	Coolant filter and valves	13/32" (10mm)	8
	&	Transmission oil dipstick tube (see step 5A)	13/32" (10mm)	8
CAC inlet pipe	&	diagonal reinforcement member	19/32" (15mm)	9
Engine air inlet pipe	&	Top of cylinder head cover	1/8" (3mm)	10

Note: If there are some places where the minimum clearance cannot be respected, correct by moving closer together the pipes at the connections. If needed, bend the pipe brackets (shown in figure 4) to meet the minimum clearance.

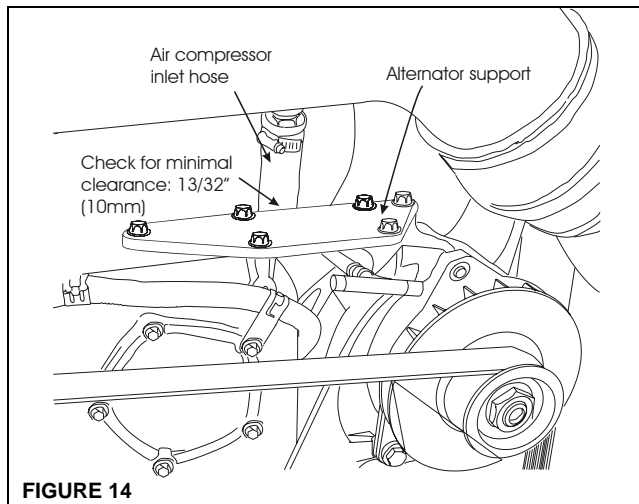
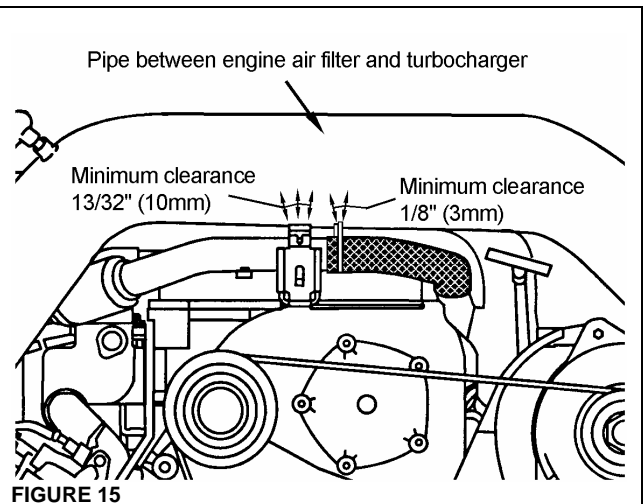
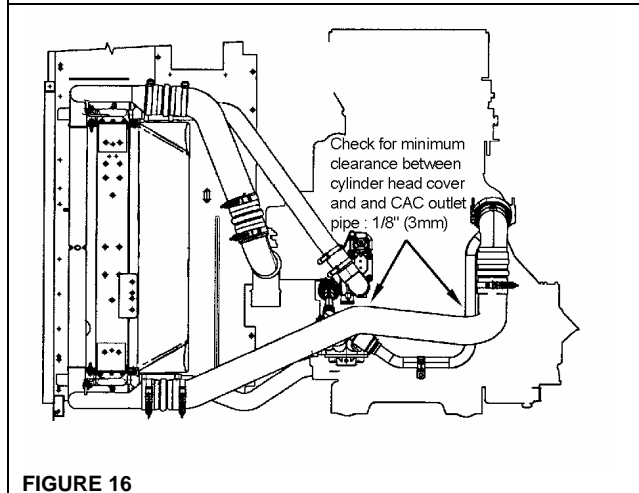
TABLE B – Minimum clearance				
COMPONENT 1		COMPONENT 2	MINIMUM CLEARANCE	FIGURE
Air compressor inlet hose	&	Bosch alternator support	13/32" 10mm	14
Pipe between engine air filter and turbocharger	&	Engine air inlet pipe	13/32" 10mm	6
	&	EGR pipe spring clamp and support	13/32" & 1/8"	15
	&	Coolant filter and valves	13/32" 10mm	8
	&	Transmission oil dipstick tube (see step 4B)	13/32" 10mm	8
	&	Rear junction box lid when open	13/32" 10mm	---
CAC outlet pipe	&	Power steering fluid reservoir (coach only)	19/32" (15mm)	---
	&	Top of the cylinder head cover	1/8" (3mm)	16

Note: If there are different places where the minimum clearance cannot be respected, correct by moving closer together the pipes at a connection.

- 5B. If your vehicle is equipped with 2 Bosch alternators and the minimum clearance cannot be met, replace the alternator support by the modified alternator support (#012264) which offers a greater clearance for the air compressor inlet hose. Tighten the screws at a torque of 43 lb-ft.
