WARRANTY BULLETIN

Wb04-16

DATE : DECEMBER 2004	SECTION : 07 - Transmission
EXPIRATION: DECEMBER 2006	
SUBJECT: MODIFICATION OF SPEED SENSOR CONNECTORS ON ALLISON WORLD TRANSMISSION

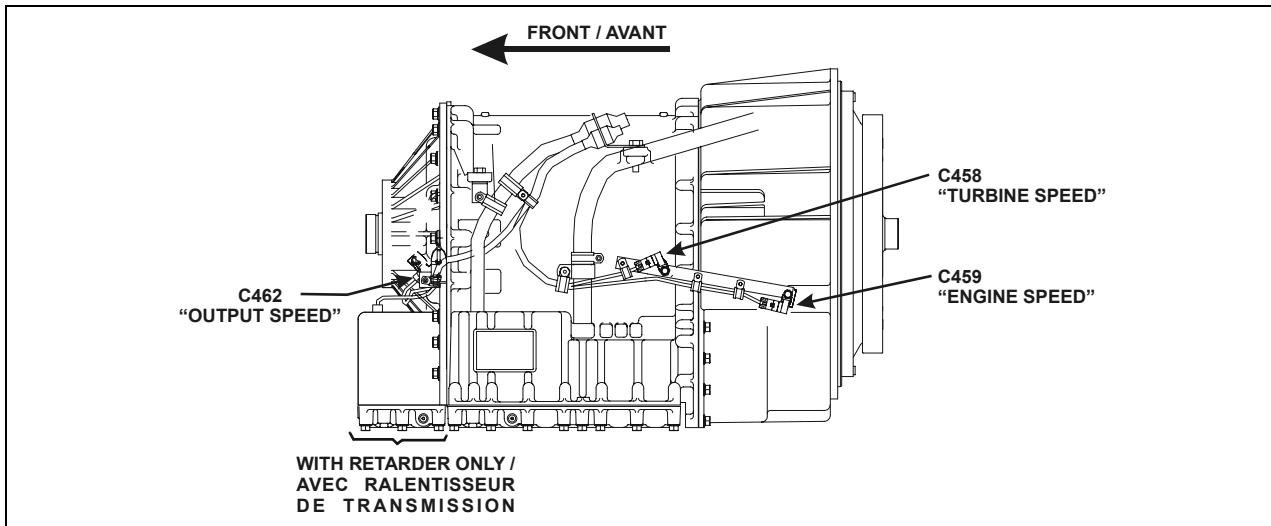
Figure 1: LOCATION OF THE CONNECTORS ON THE TRANSMISSION HOUSING

Allison, manufacturer of the World B500 transmission advised Prevost Car that a problem with the speed sensor connectors could happen. The connectors can unplug from the transmission housing or become loose because the locking device does not engage properly. The transmission knocks when shifting or can shift to neutral when that situation happens. A vehicle breakdown can occur. These problems generate the following error codes: 22-14, 22-15, 22-16 and 22-11. **If your vehicle is equipped with a ZF-Astronic transmission, please do not consider this bulletin.**

1. Using figure 1, locate the 3 speed sensor connectors which have to be modified (on transmission housing, left side of vehicle): C458 "TURBINE SPEED", C459 "ENGINE SPEED", C462 "OUTPUT SPEED".
