**WARRANTY
BULLETIN**

Wb08-13

| SUBJECT : REPLACEMENT OF THE DASHBOARD STATIONNARY REGENERATION SWITCH - DETROIT DIESEL S60 ENGINE ONLY | |

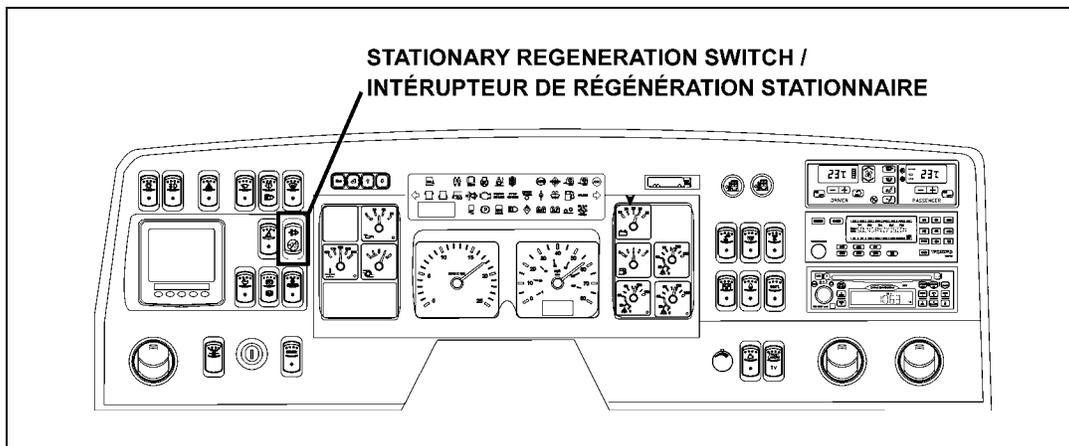
On all vehicles mentioned above (with Detroit Diesel S60 engine), it is necessary to replace the existing dashboard regeneration switch. Prevost has determined that this switch would not be able to initiate a stationary regeneration after a DDEC VI software upgrade.

1. Remove the dashboard cover.

Before removing the existing switch, check the part number on the label affixed on the switch housing. If you read Prevost part number #564106, the switch in place is the new one and it does not need replacement.

2. Unplug the connector behind existing regeneration switch.
3. From behind the dashboard, press the tabs on the switch housing and remove the switch. The switch will come out on the front side of the dashboard.
4. Insert the new regeneration switch and plug the connector.
5. Reinstall the dashboard cover.
