**PREVOST****BULLETIN
DE
GARANTIE**

Bg08-13

DATE : JUILLET 2008	SECTION : 06 - Électricité
EXPIRATION: JUILLET 2010	
SUJET : REMPLACEMENT DE L'INTERRUPTEUR DE RÉGÉNÉRATION STATIONNAIRE DU TABLEAU DE BORD – MOTEUR DETROIT DIESEL SÉRIE 60

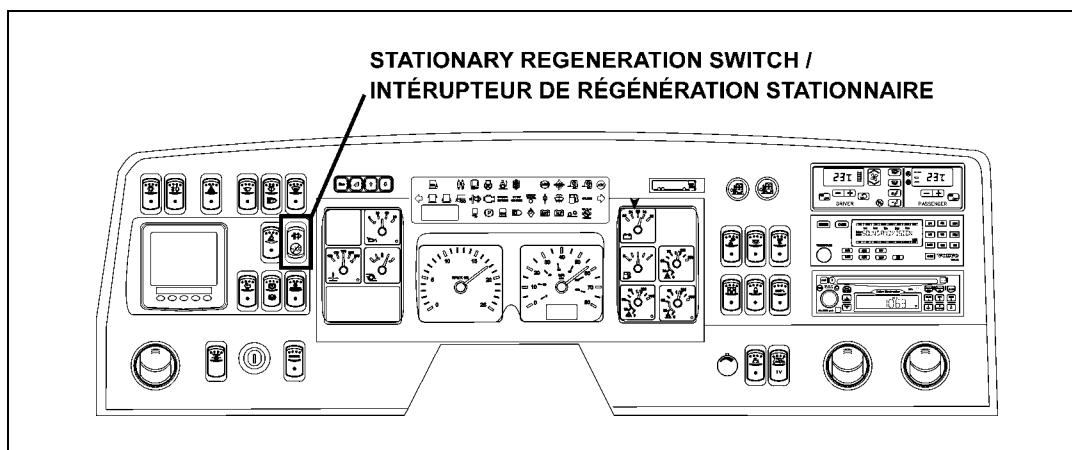
Sur les véhicules ci-haut mentionnés, il est **absolument nécessaire** de remplacer l'interrupteur de régénération stationnaire situé sur le tableau de bord, à défaut de quoi, il sera impossible d'enclencher une régénération, suite à une mise à jour de la programmation du système de contrôle DDEC VI de Detroit Diesel. Noter que ce remplacement est nécessaire seulement pour les véhicules munis d'un moteur Detroit Diesel Série 60.

Il est impératif que l'interrupteur soit remplacé AVANT que le véhicule soit amené chez un distributeur Detroit Diesel pour une mise à jour de la programmation DDEC VI. Si la mise à jour est faite avant le remplacement de l'interrupteur de régénération stationnaire, celui-ci ne sera plus fonctionnel.

1. Retirer le couvercle du tableau de bord.

Avant de retirer l'interrupteur en place, vérifiez-en le numéro de pièce Prevost sur l'étiquette apposée sur le boîtier de l'interrupteur. Si il est indiqué 564106, il s'agit du nouvel interrupteur et celui-ci n'a pas besoin d'être changé.

2. Débrancher le connecteur de l'interrupteur actuellement en place.
3. Par l'arrière du tableau de bord, pincer les pattes de retenue de l'interrupteur actuellement en place et retirer l'interrupteur. Celui-ci sortira par l'avant du tableau de bord.
4. Insérer le nouvel interrupteur puis brancher le connecteur.
5. Remettre le couvercle du tableau de bord en place.
