**WARRANTY  
 BULLETIN**

Wb09-16

<b>DATE :</b> NOVEMBER 2009	<b>SECTION :</b> 23 - Accessories
<b>EXPIRATION:</b> NOVEMBER 2011	
<b>SUBJECT :</b> AUTOMATIC FIRE DETECTION AND SUPPRESSION SYSTEM (AFSS) - REROUTING LINEAR THERMAL DETECTOR (LTD)

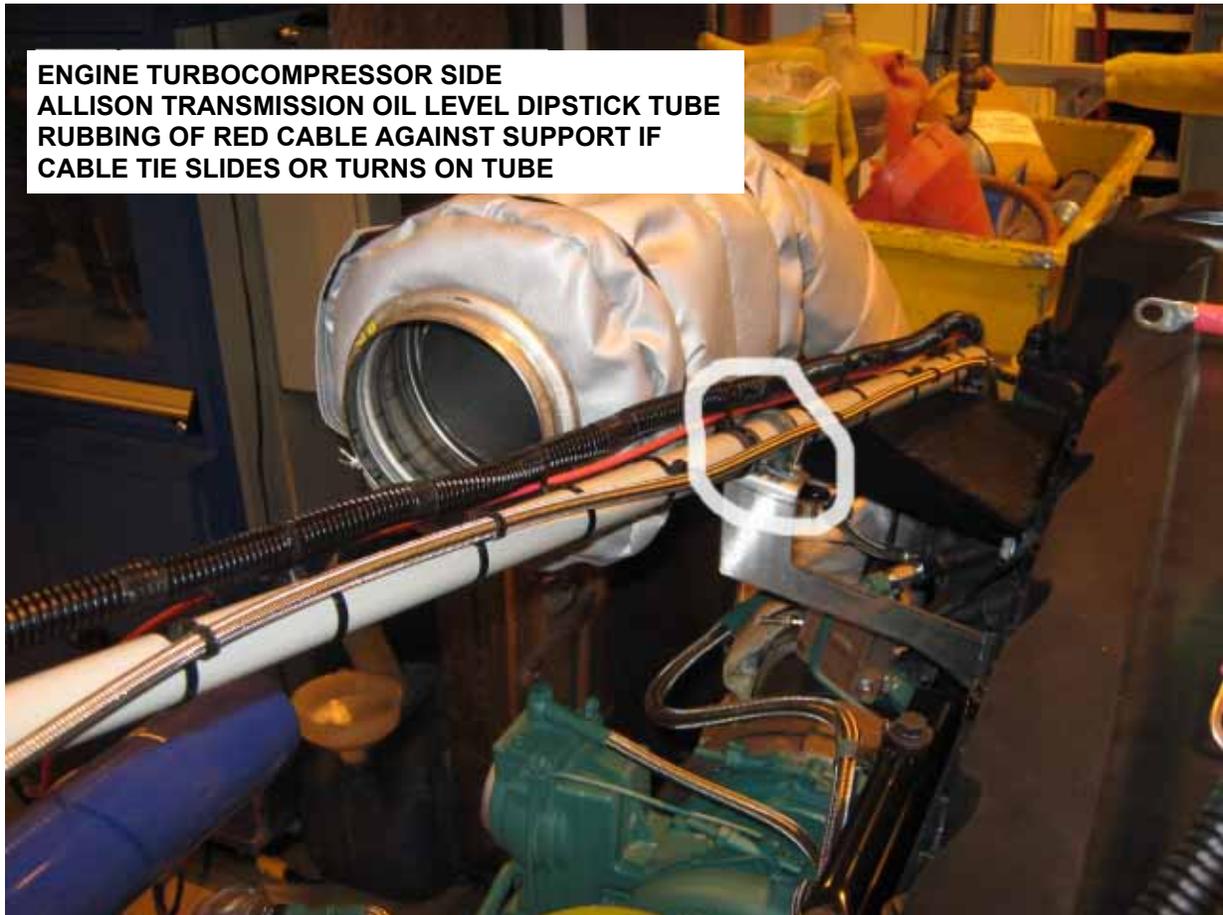
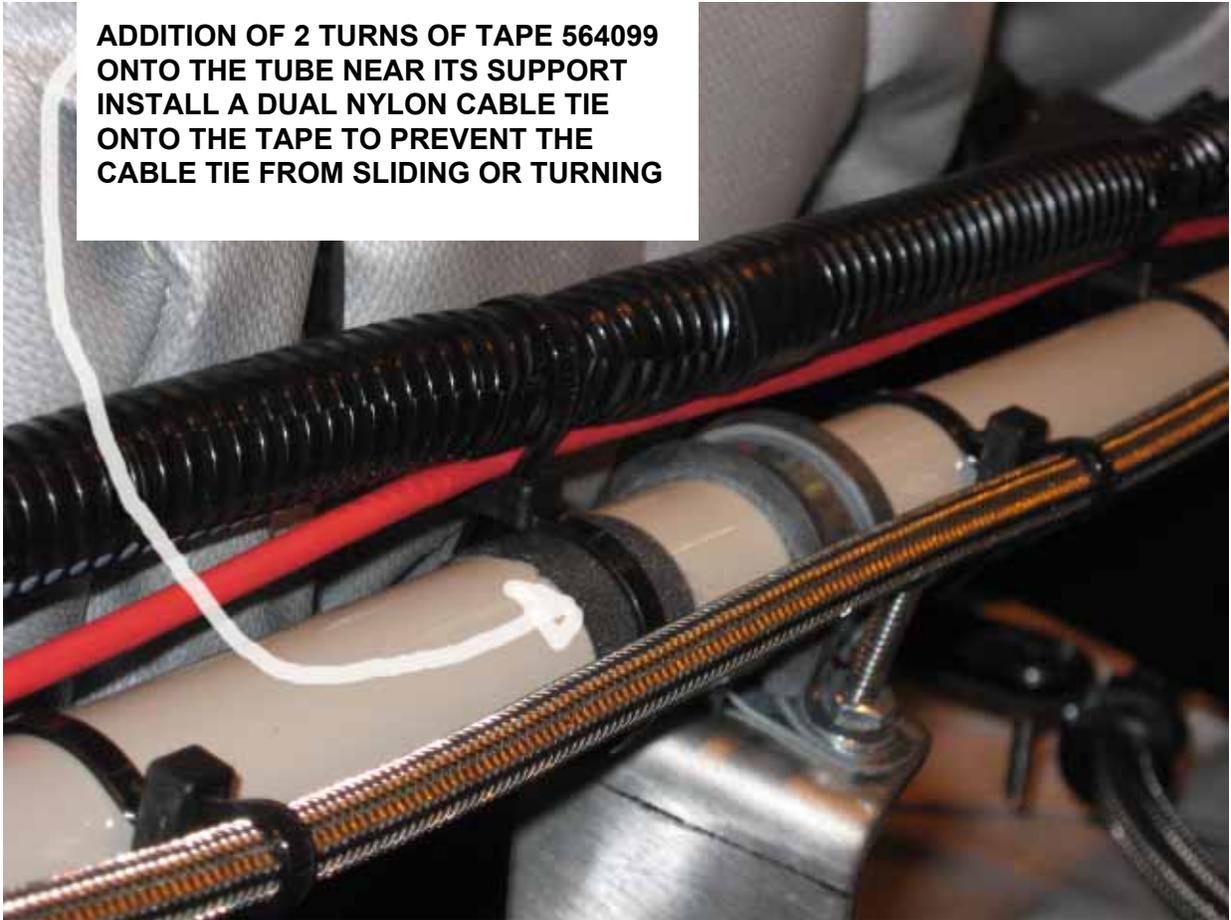
This will prevent the red cable from rubbing against the support.

On engine turbocompressor side, on Allison transmission oil level dipstick tube, add two turns of tape 564099 onto the tube near its support and fix linear thermal detector (red cable) by installing a dual nylon cable tie onto the tape to prevent the nylon cable tie from sliding and turning on the tube.

**ADDITION OF 2 TURNS OF TAPE 564099  
ONTO THE TUBE NEAR ITS SUPPORT  
INSTALL A DUAL NYLON CABLE TIE  
ONTO THE TAPE TO PREVENT THE  
CABLE TIE FROM SLIDING OR TURNING**
