**WARRANTY
BULLETIN**

Wb09-17A

DATE : DECEMBER 2009	SECTION :	18 - Body
EXPIRATION: JUNE 2012		
SUBJECT : INSPECTION OF WELD BEADS ON 85" SUPER CARGO DOOR PANTOGRAPH ARM

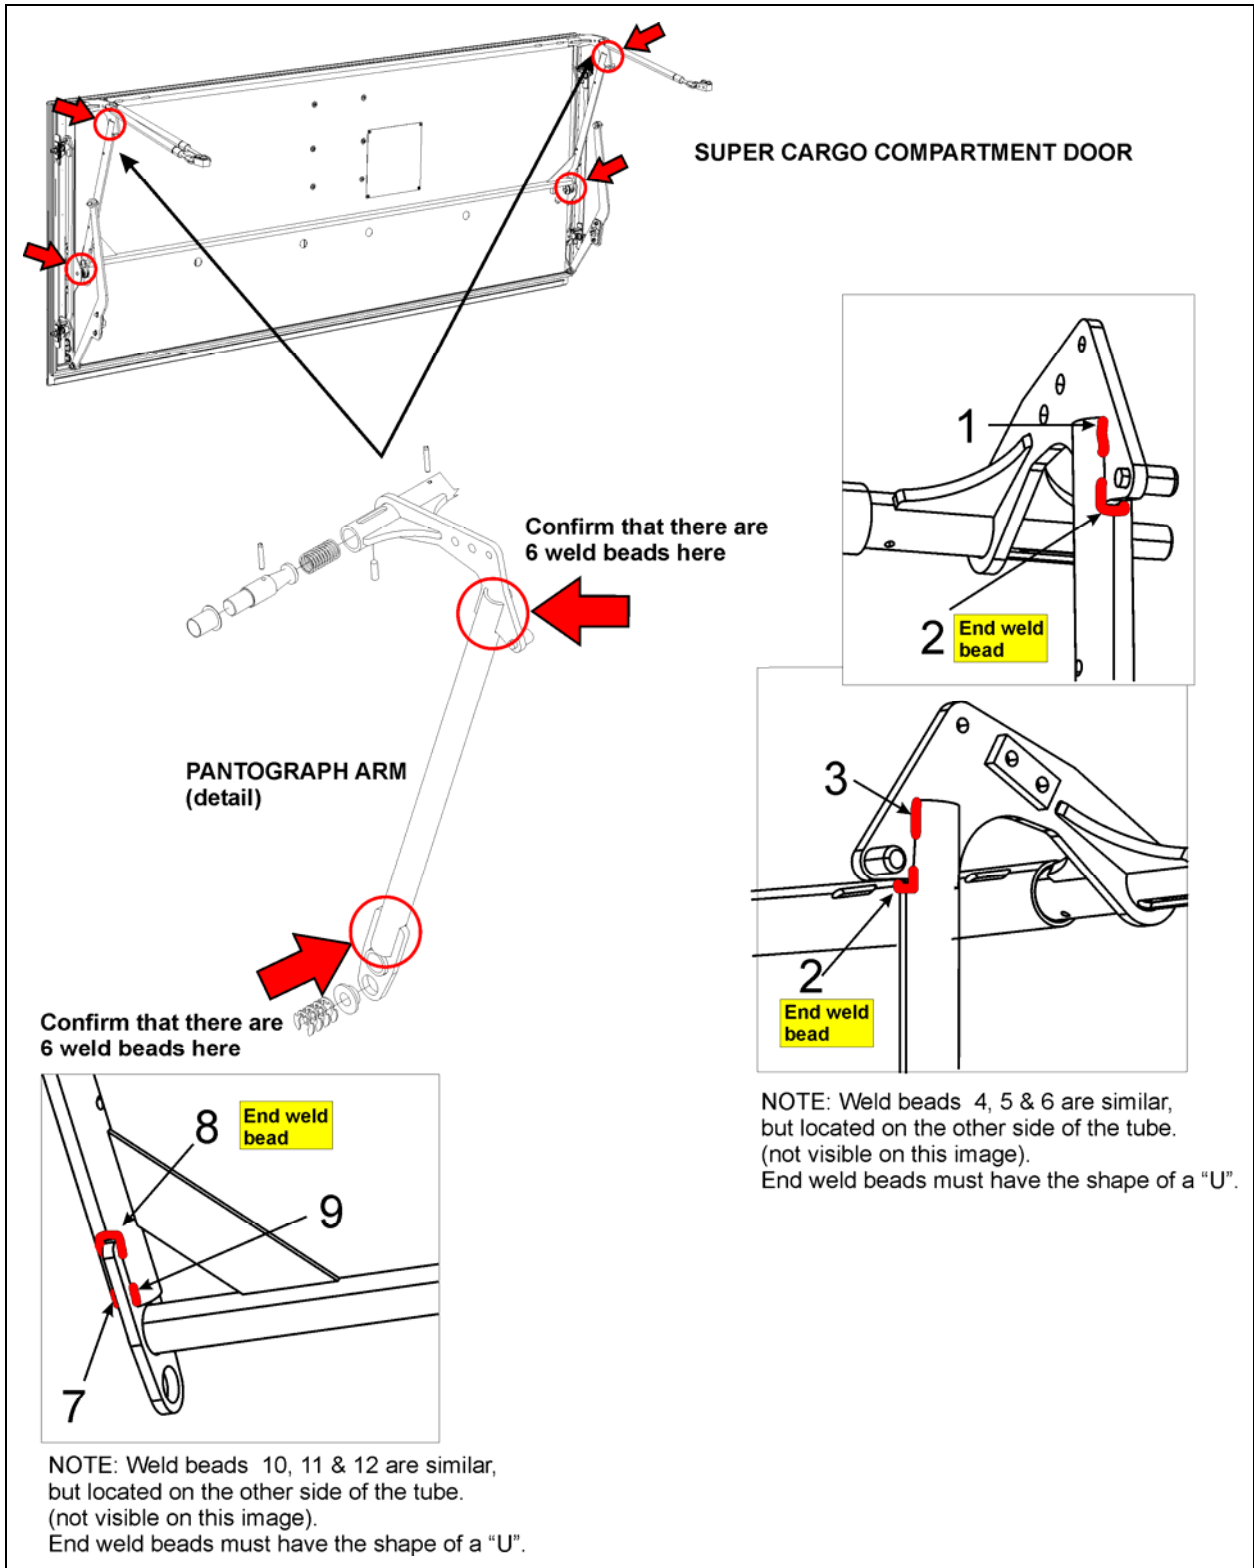
FIGURE 1: INSPECTION

On the vehicles affected by this bulletin, it is absolutely necessary to inspect weld beads on each super cargo door pantograph arms. Some weld beads might be missing which could lead to fatigue cracking, thus the pantograph arm can lose its strength and become unsafe.

- 1 Inspect as per figure 1. Make sure that the 24 weld beads are present on the pantograph arm (24 weld beads per door, 2 doors to be inspected). Furthermore, end weld beads (a total of 4) must have the shape of a « U ».
- 2 If at least, one weld bead is missing, go directly to Part 2 for replacement of the pantograph arm. If the end weld beads do not form a « U », proceed to Part 2 for replacement of the pantograph arm assembly #288783.
- 3 Following this inspection, if no weld beads are faulty, it is not necessary to replace the pantograph arm assembly #288783.

Only if weld beads are missing, it will be necessary to replace the pantograph arm because a repair is not permitted due to the coating applied on the steel members. The pantograph arm is considered as defective if weld beads are missing and must be replaced.
