WARRANTY BULLETIN

Wb10-30

DATE : JULY 2010	SECTION :	12 - Brakes
EXPIRATION: JULY 2012		
SUBJECT : RELOCATING ABS AND ATC CABLE IN REAR WHEELHOUSING

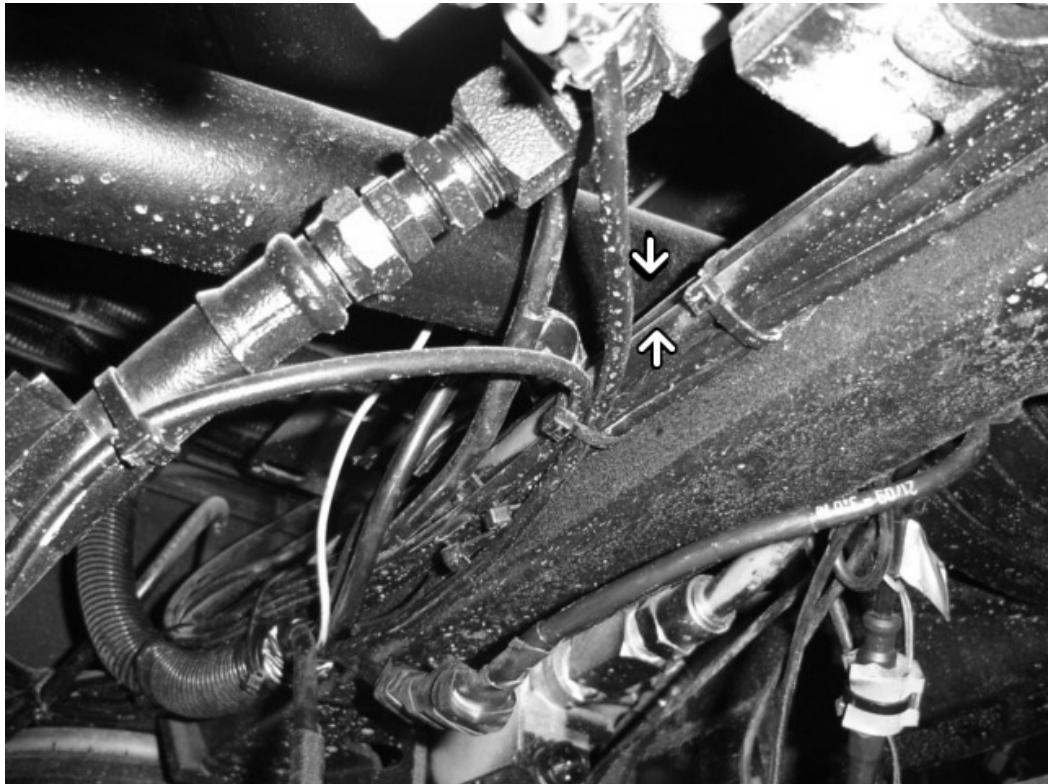
1. In the rear wheelhousing, locate the ABS and ATC cable on the structure horizontal cross member.

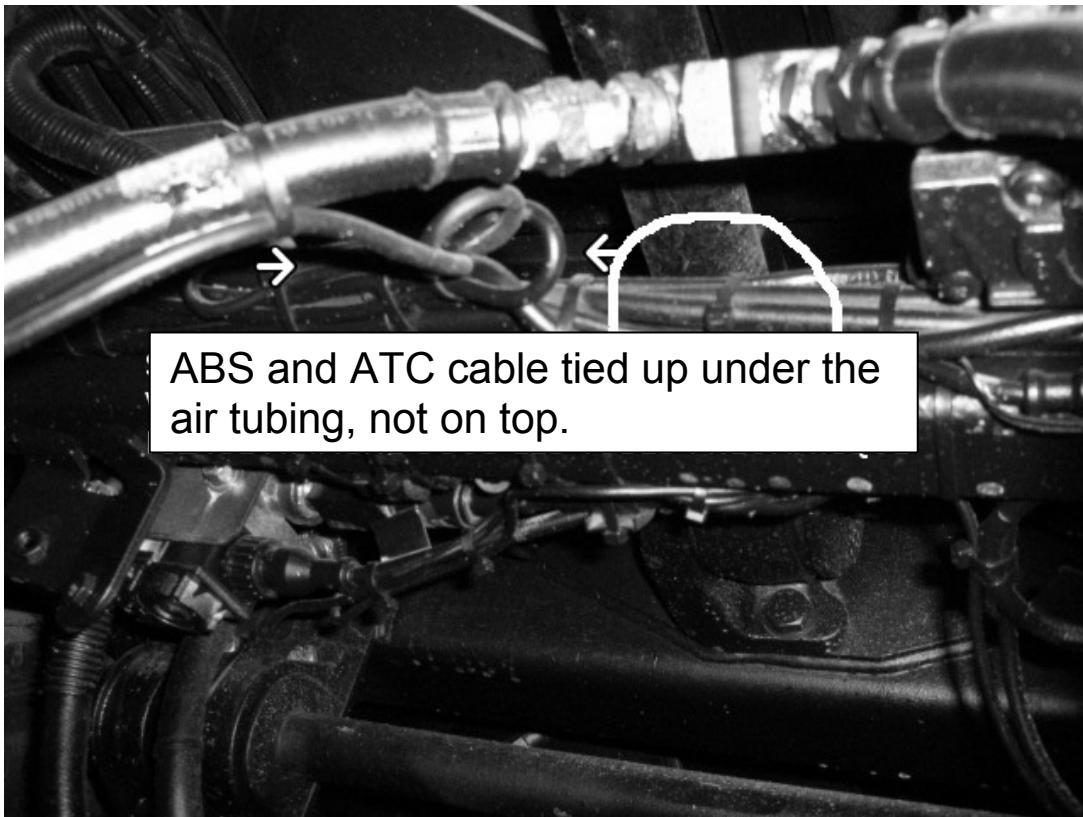
2. To prevent the ABS and ATC cable from coming in contact with the longitudinal radius rod, check that it is tied up under the air tubing and not on top.
