PREVOST

WARRANTY BULLETIN

WB12-15A

DATE : JULY 2012	SECTION :	04 - Exhaust
EXPIRATION: JULY 2014		
SUBJECT : EXHAUST BELLOWS INSPECTION AND ADJUSTMENT

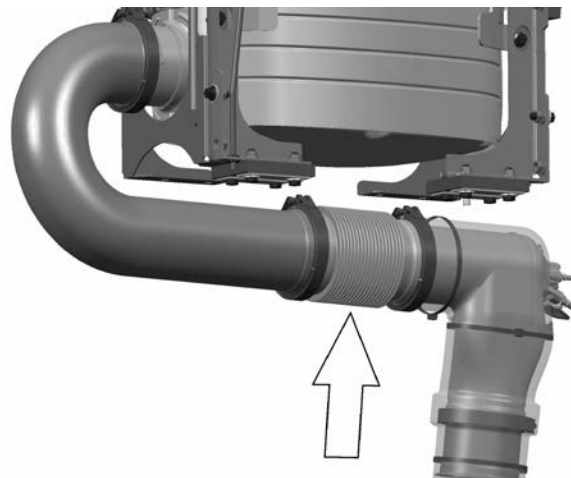
On the vehicles affected by this bulletin, inspection of one of the exhaust bellows is required.

If the exhaust bellows offset is not within specific values, a corrective procedure must be performed.

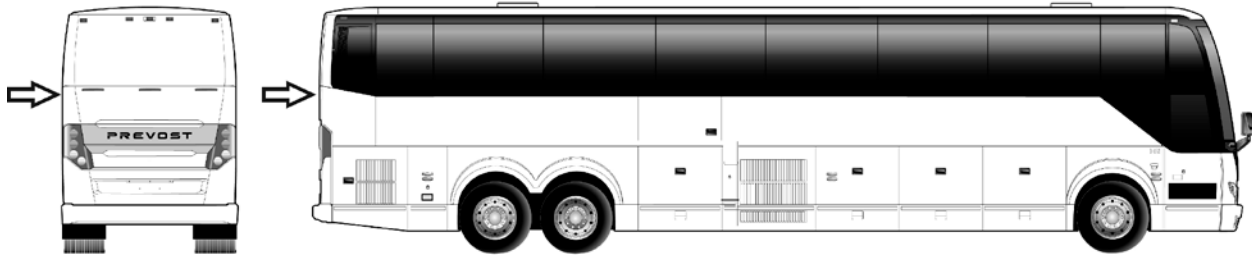
1. Open the Diesel Particulate Filter (DPF) access door.

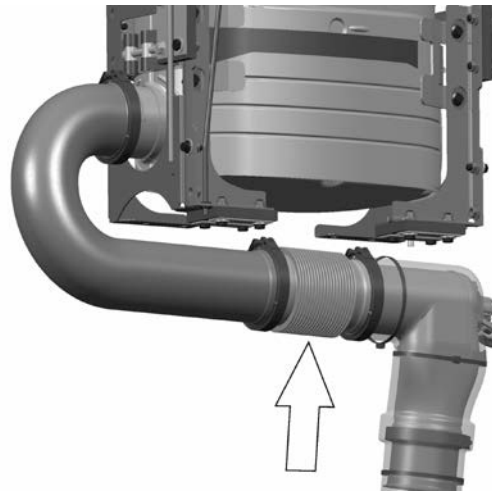
2. Remove the insulating sleeve over the bellows.

In the next steps, we will check bellows offset variation and bellows segment gaps.

If the inspection reveals there is an exhaust leak, replace the bellows and any damaged surrounding parts.

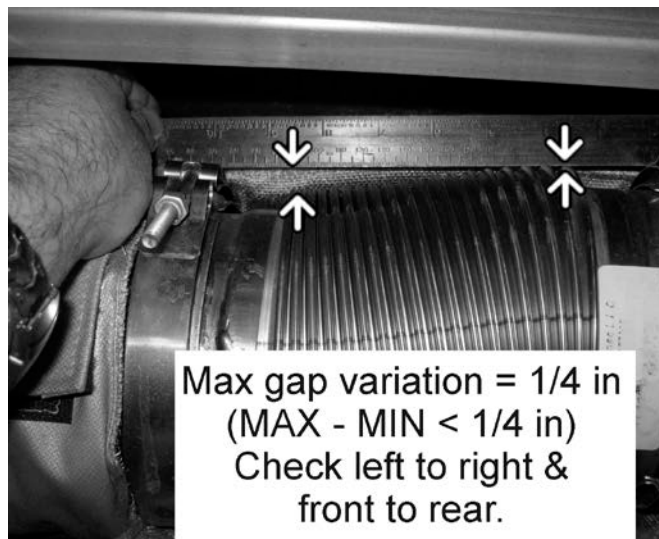
3. Place ruler on clamps as shown, on top of bellows clamps. Check bellows vertical gap variation measured left to right.

Maximum gap variation allowed is 1/4".

For example:

On the left side we measure 1/2".

On the right we measure 1/4".

Variation equals to:

$$1/2" - 1/4" = 1/4"$$

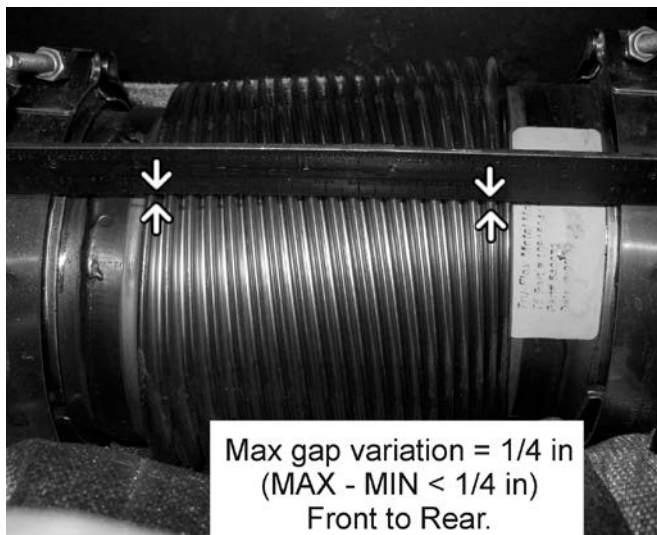
4. Check bellows gap front to rear.
Maximum gap variation allowed is 1/4".

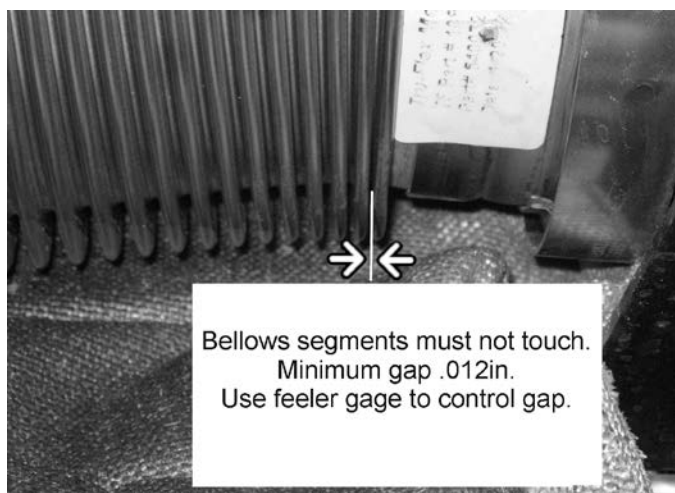
5. Check bellows segment clearance.
Each bellows segment should have a .012 in. clearance.
Measure gap with feeler gage.

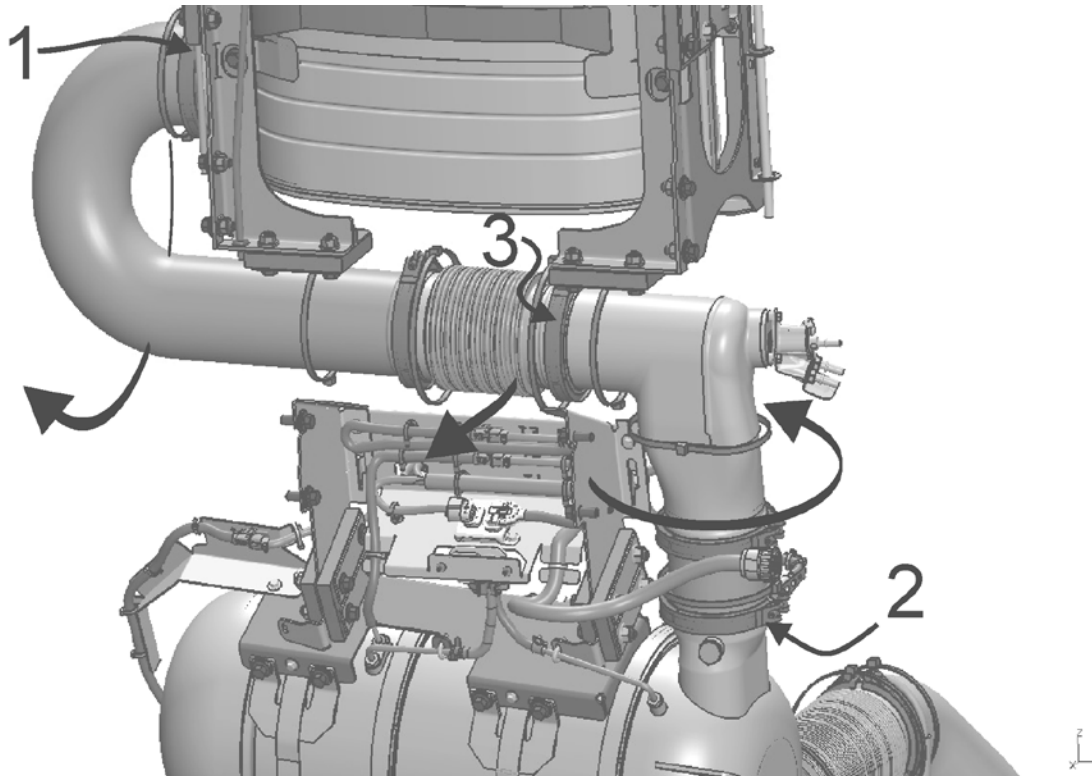
6. If bellows offset is not within the prescribed limits. Carry-out this correction.
Slack V-clamps 1, 2 and 3 just enough to allow rotation.
Rotate « J » pipe (1) as shown, towards the back.
Pull bellows (3) towards the back.
Swirl pipe (2) may need to be rotated slightly as shown.

Make sure the DEF connectors on swirl pipe do not touch the bus structure.

Replace any damaged part.

Once bellows offset and segment gap is within limits, tighten V-clamps to 100 lbf-in (8 lbf-ft)

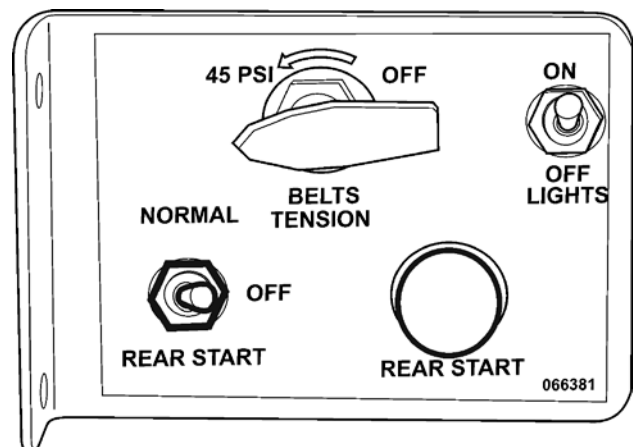
7. Set battery master switch to the ON position.
In a properly ventilated area, activate rear start switch and start the engine.
Confirm all joints are sealed and that there are no exhaust leaks.
Re-install insulating sleeves with cable tie 504737.
