PREVOST

**WARRANTY
BULLETIN**

WB13-48A

DATE :	AUGUST 2013	SECTION :	07 - Transmission
EXPIRATION:	AUGUST 2015		
SUBJECT :	RETARDER COOLER PIPING SUPPORT - WELD INSPECTION AND REPLACEMENT

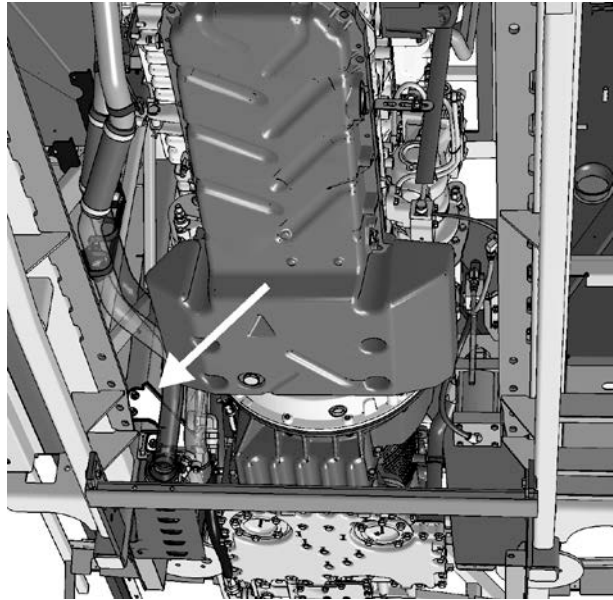
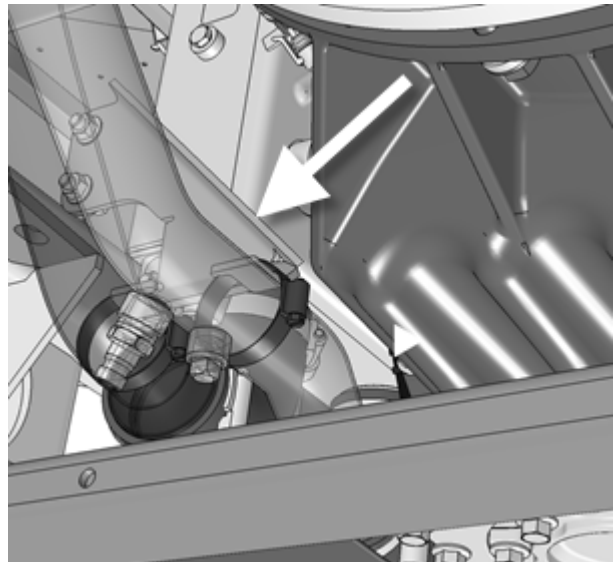
1. Lift the vehicle and locate the oil cooler pipe support. It is located left of the transmission

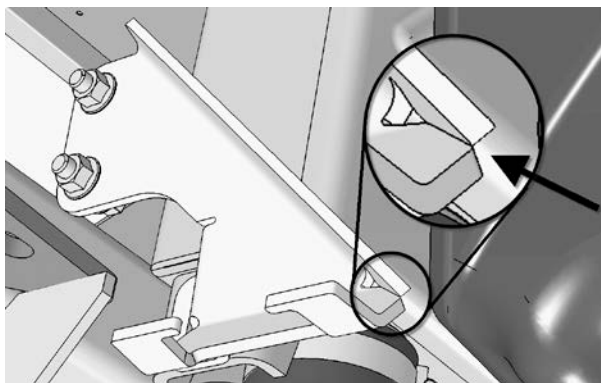
2. Using a telescopic inspection mirror, Make sure there is a weld fillet at this location on the piping support.

(Piping removed for clarity)

If there is a weld present, no further action is required.

If there is no weld, the part should be replaced.

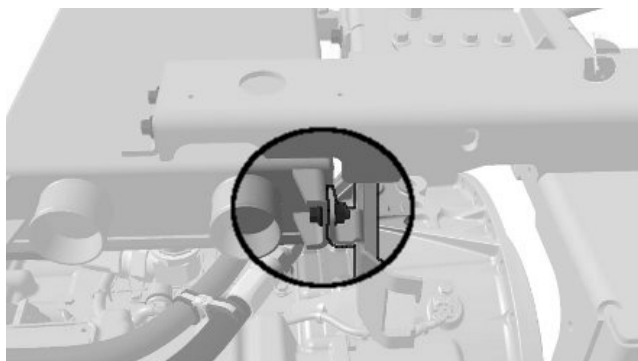
View from bottom

This should give you access to the support bolts.

1. Close the heating valves and make sure vehicle has cooled down for next steps.
2. Empty the coolant in an appropriate container.
3. Create some working space by removing the piping clamps, inlet and outlet piping and elbows. Collect any coolant left at this point.

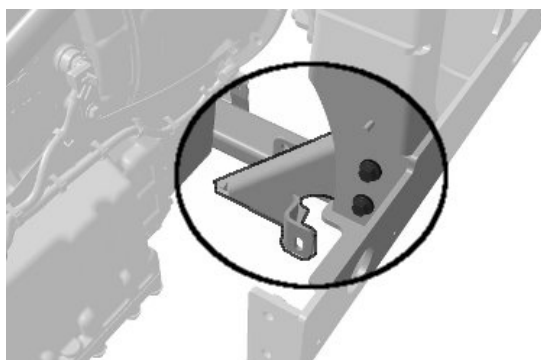
Reverse angle.

4. Remove and discard the piping support and replace with the new part.
Tighten to 32 lbf-ft (44 N-m)
5. Re-install the piping and elbows.
6. Fill the coolant system.
7. Re-open heating valves.
8. Check cooling system for leaks and vehicle for proper operation.
