PREVOST

**WARRANTY
BULLETIN**

WB13-55A

DATE :	AUGUST 2013	SECTION :	05 - Cooling
EXPIRATION:	AUGUST 2015		
SUBJECT :	WELD INSPECTION ON TRIPOD FAN SUPPORT

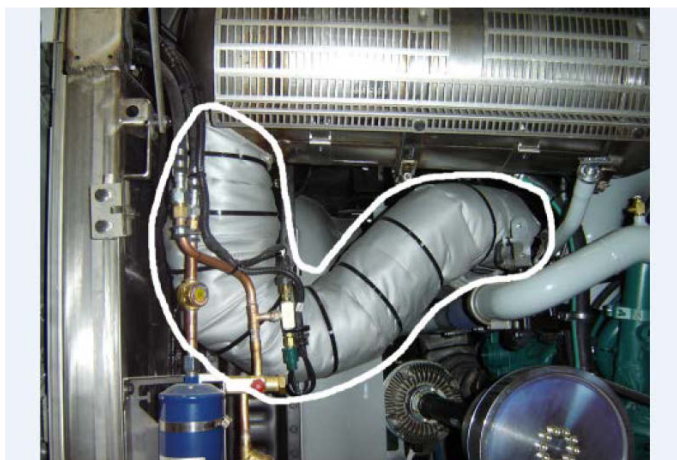
a. Clear the two (2) V-band clamps hidden under the insulating blanket at the junction with the DPF and at the junction with the exhaust flexible section.

b. Undo the two (2) V-band clamps identified on the image.

c. Unscrew the nut at the support bracket.

d. Remove this section of exhaust pipe.

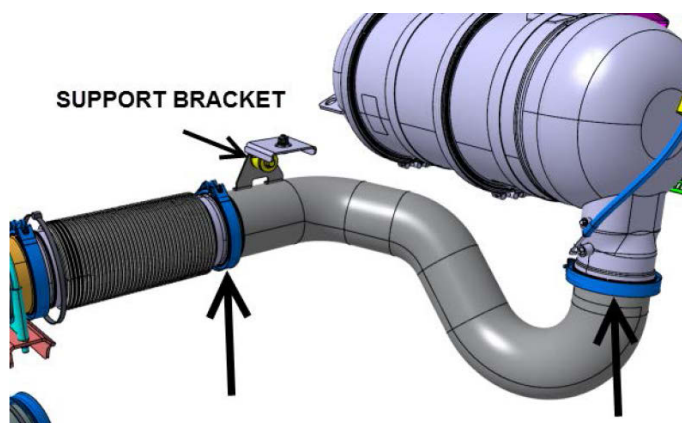
4. Use a telescopic mirror to inspect the support.

5. If there is no weld at the indicated locations, replace 053024.
