# **PREVOST *Warranty Bulletin***

**NO:** 94-23  
**SECTION:** 13

**SUBJECT:** HUB BEARING ADJUSTMENT FOR GKN MADE AXLE

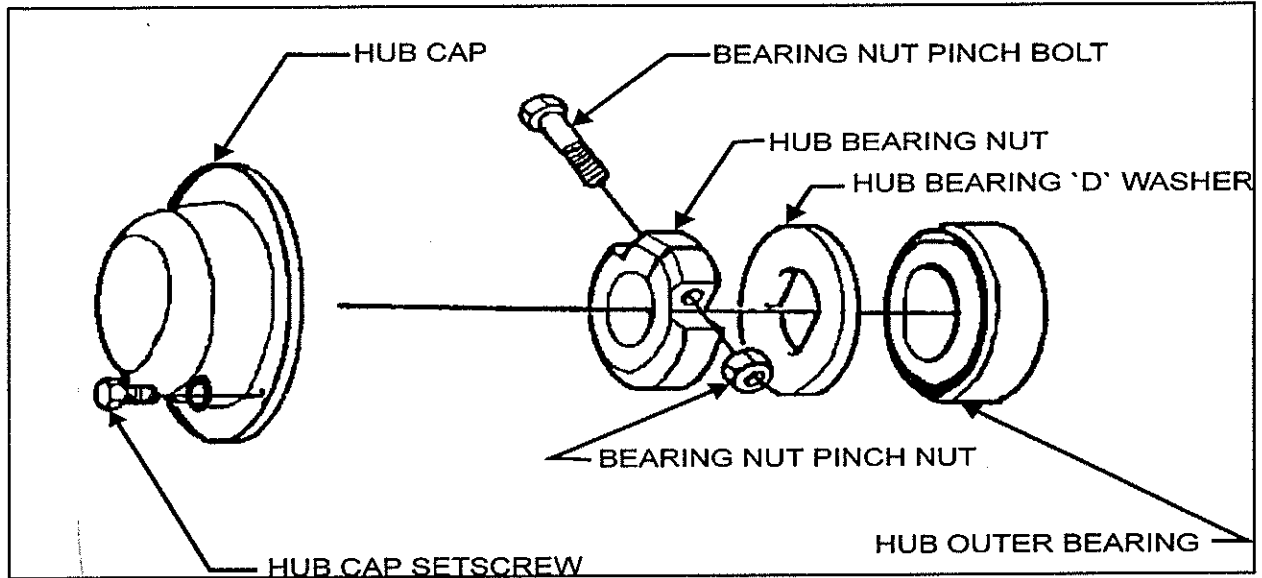
Figure 1

Some H3-41 and H3-45 vehicles equipped with front and tag axles made by GKN have a wrong cone bearing adjustment. To detect it, grasp the tire by the two opposite points on its perimeter and rock it to see if there is a slack.

The hub bearings affected by a slack should be readjusted by the following procedure (see fig. 1):

1. Park vehicle over a safe lifting equipment. Apply parking brake, stop engine and set battery main switches to the "OFF" position. Raise the vehicle by its jacking points on the body. Consult H3-40 Maintenance Manual, Section 18 under heading "Vehicle Jacking Points".
2. Remove the hub cap by unscrewing hub cap setscrew.
3. Unscrew the bearing nut pinch nut.
4. Screw the bearing nut at the end of the spindle until the elimination of the slack without creating stress on the bearings.
5. Tighten the hub bearing pinch bolt nut to 24-26 lbf·ft (33-35 N·m) and the hub cap setscrew to 85-103 lbf·ft (115-140 N·m).
