# PREVOST

## Warranty Bulletin

95-15

Date: April 1995  
Section: 06  
Subject: Upper Windshields Wipers  
Application:

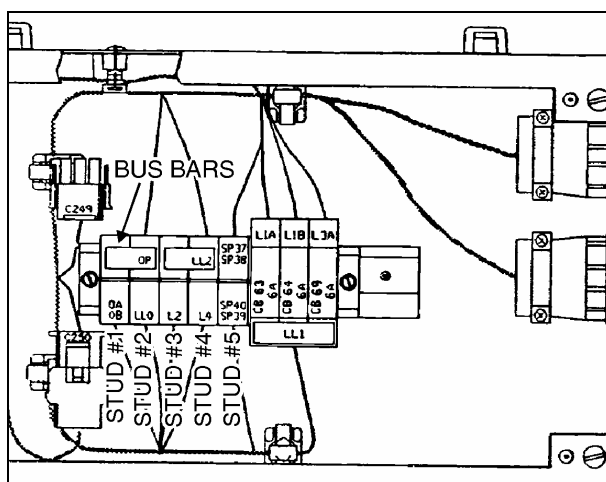
FIGURE 1

On the above-mentioned vehicles, a problem may affect intermittent mode on upper windshields wipers. This problem is caused by a poor ground. If you have experienced this problem on your vehicle, we recommend you to correct it as per the following procedure.

1. In front service compartment, open alarm junction box.
2. Remove the bus bars on studs #1 and #2 (Fig.1).
