PREVOST

Warranty Bulletin

96-04

Date: **April 1996**
 Section: **18**
 Subject: **Frame Reinforcement**
 Application:

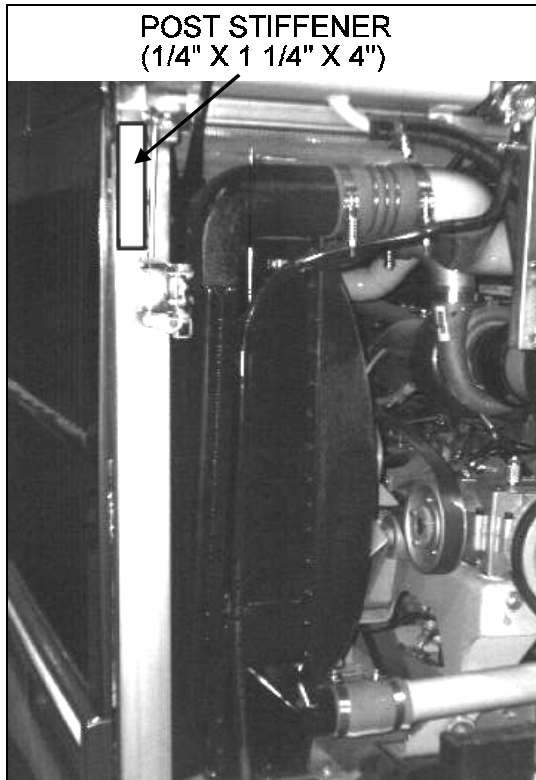
FIGURE 1: ENGINE COMPARTMENT

POST STIFFENER
(1/4" X 1 1/4" X 4")

1. Open rear engine door.
2. Locate the rear left vertical post (Fig. 1).
3. Open radiator door (to protect paint).
4. Clean and grind post surface to reasonable flatness.
5. Protect paint from sparks with fireproof material.
6. Weld the stiffener on the post as per figure 2. Refer to the General Welding Procedure in this Warranty Bulletin.

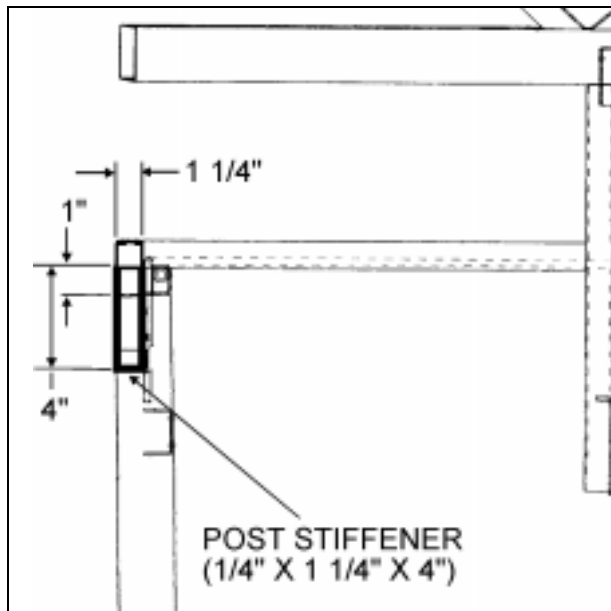
FIGURE 2: ENGINE COMPARTMENT

POST STIFFENER
(1/4" X 1 1/4" X 4")
