PREVOST

Warranty Bulletin

97-06

Subject: GRINDING OF INDEPENDENT FRONT SUSPENSION LINKS BOSSES

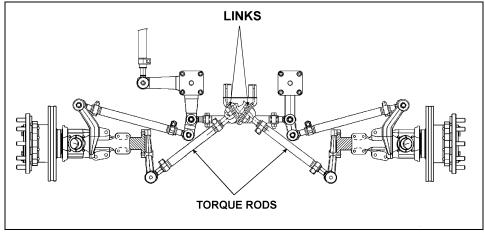
FIGURE 1: INDEPENDENT FRONT SUSPENSION LINKS

On the above-mentioned vehicles, fouling exist during travel of the suspension between the torque rods and their links which are located in the front subframe. In order to correct this defect, grinding of the two bosses located within the links of the torque rods is necessary.

- 2. Remove the wheels if needed.
- 3. Exhaust air from air springs by opening the drain cock on each air spring tank. Close each air spring tank drain cock. The drain cocks and the tanks are located in front subframe.
- 4. Remove the bolts from the torque rods links. Using a pry bar, move the torque rods out of the way to have access to the links bosses (refer to fig. 1).
