**WARRANTY
BULLETIN**

Wb99-04

DATE : JANUARY 1999	SECTION : 23 - Accessories
EXPIRATION: JANUARY 2000	
SUBJECT : LAVATORY DRAIN PIPE REPLACEMENT

Model	VIN
H3-41 and H3-45 Coaches Model Year : 1996 - 1999	From 2PCH33493I1011572 up to 2PCH33491X1012970 incl.

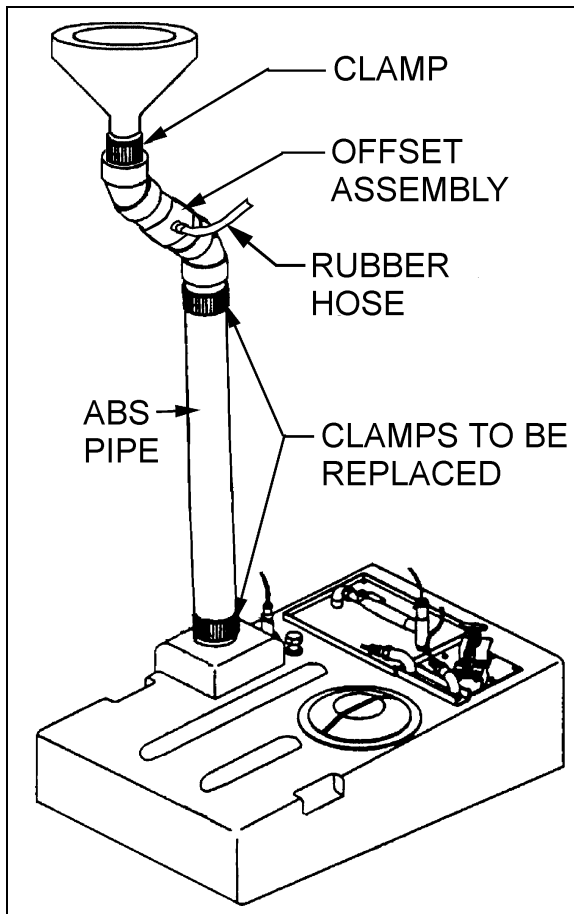
FIGURE 2: DRAIN PIPE (BEFORE MODIFICATION)

On the above-mentioned vehicles, drain pipe rigidity of mounting may cause offset assembly to crack. Replacement of rigid ABS pipe with flexible tubing prevents this situation from happening.

2. Removal of garbage bin gives access to the offset assembly through an opening in the lavatory wall. Locate through this opening the rubber hose used for toilet bowl ventilation (refer to figure 2).

3. Unfasten rubber hose clamp screw as well as clamp securing offset assembly to toilet bowl sleeve.
4. Open engine compartment rear door and engine compartment R.H. side door. Unfasten ABS pipe clamp screws, remove clamps and ABS pipe as well as offset assembly (refer to figure 2).
5. Install new offset assembly to toilet bowl sleeve and secure using clamp. Fix also rubber hose clamp. Install flexible tubing (Prévost #402418) together with new clamps (Prévost #504235).
6. Perform drain pipe test to ensure no leaks are present. Tighten clamp screws as needed.
