# WARRANTY BULLETIN

Wb99-19

SUBJECT: SECURING OF PARCEL RACKS

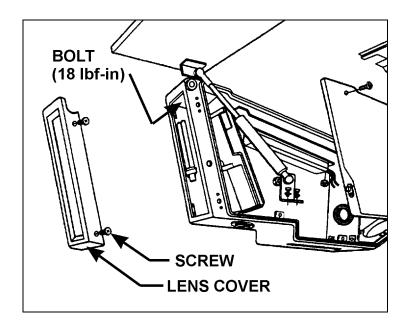
On the above-mentioned vehicles, some of the bolts securing the parcel racks may not have been properly fastened. Retorquing the bolts is necessary for proper parcel racks fixation.

- 1. Remove the four screws securing the lens cover (refer to figure 1). Remove the lens cover.
- 2. Locate the bolt securing the parcel rack (refer to figure 1). Retorque the bolt to 18 lbf-in (1.98 N·m).
- 3. Carry on with the fore-mentioned procedure for all bolts.
- 4. Reinstall the lens covers.
