REVISION n/a: THIS WARRANTY BULLETIN SUPERSEDES PREVIOUS VERSION.

BROKEN EXHAUST CLAMP AT TURBOCHARGER DIFFUSER PIPE 9700 (B13R)

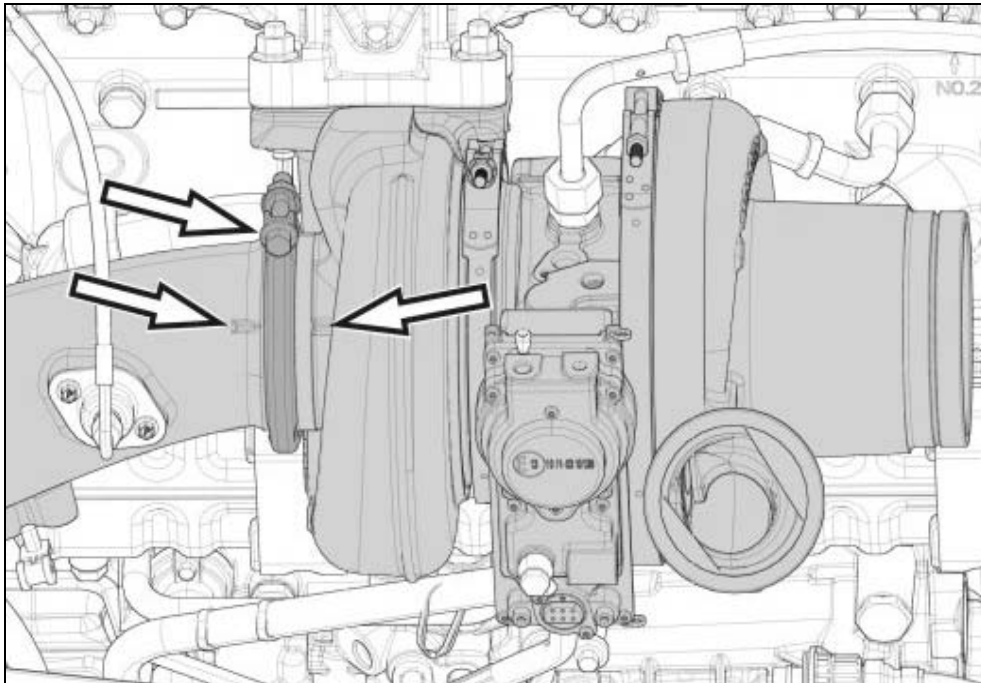
NOTE: WHEN POSITIONING THE DIFFUSER PIPE, ALIGN THE MATCH MARKS ON THE DIFFUSER AND ENGINE TURBOCHARGER, IF EQUIPPED

- 1) Remove the radiator (refer to: Function group 26).
- 2) Replace the turbocharger outlet pipe V-band clamp. Use a new gasket between the diffuser and turbocharger. Turn the diffuser pipe to the correct position (see figure below). Tighten the clamp to the proper specification. **V-band clamps..... 10 ± 2 Nm (90 ± 9 in-lb)**
