PREVOST

WARRANTY BULLETIN

WB15-53A

DATE :	NOVEMBER 2015	SECTION :	04 - Exhaust
EXPIRATION:	NOVEMBER 2017		
SUBJECT :	DIESEL PARTICULATE FILTER (DPF) – LOOSE PLUGS

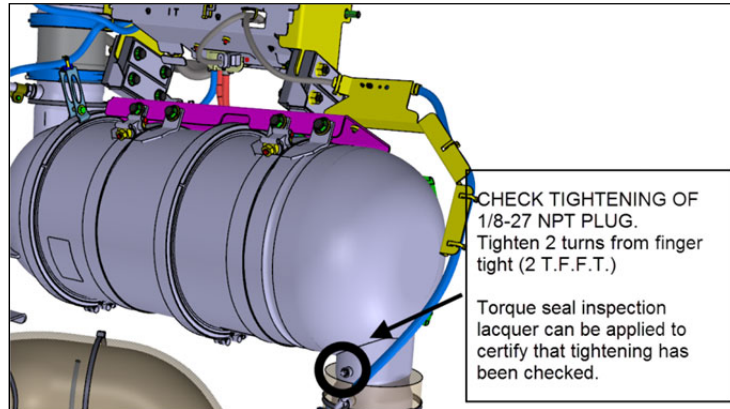
SECOND PLUG

1. Check if the 1/8-27 NPT plug located to the left side of the DPF (at the inlet of DPF) is properly tightened.

Note: To gain access to the plug, detach the Velcro strip on the insulating sleeve.

2. Tighten 2 turns from finger tight (2 T.F.F.T.).

If the plug is missing, order plug #21305581.

THE VEHICLE MUST NOT BE USED IF A PLUG IS MISSING.
