Date	Expiration	Group	No.	Page
11.2015	11.2016			1(4)

SPOT LIGHTS NOT WORKING 9700 (B13R)

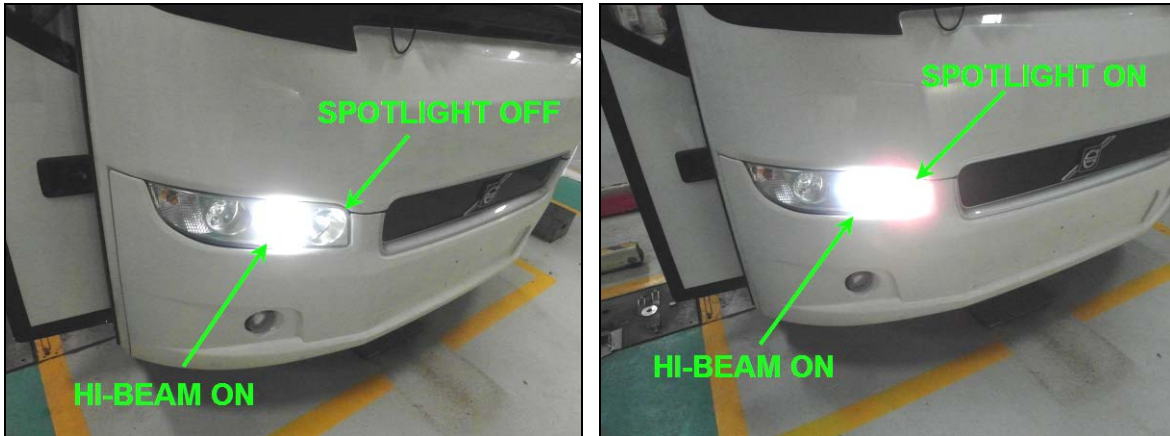
The spot lights are located toward the center of the vehicle in the headlight assembly and should light-on when the switch is in the Normal + Spot Light position and the high beams are selected.

If the spot lights fail to light or they only blink on and go off, the vehicle Lighting Control Module (LCM) harness pin out must be modified as per the drawing below.
