PREVOST

WARRANTY BULLETIN

WB17-14B

DATE :	May 2017	SECTION :	06 ELECTRICAL
EXPIRATION:	May 2019		
SUBJECT :	INSPECTION/REPLACEMENT OF ALTERNATOR POWER CABLE STUD ADAPTER

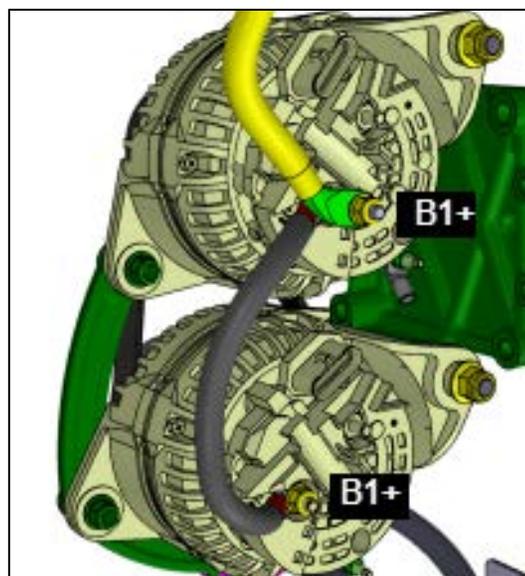
Figure 1

Using a multimeter, probe the alternator terminal **B1+** and the ground terminal. Make sure that the voltage reading is 0 volt prior disconnecting the alternator cables.

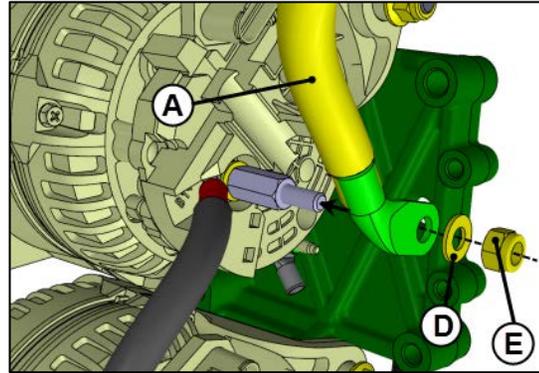
FIGURE 2

1. Remove existing hexagonal locknut **E**, flat washer **D** and power cable **A** from the stud adapter.

The existing locknut must be replaced as it is one-time use only.

The existing M8 nut « E » #5001787 is canceled and replace by nut #5001983.

2. Discard old locknut **E**.
3. Clean the anti-corrosion compound that was applied on the stud adapter **B** especially between flats.

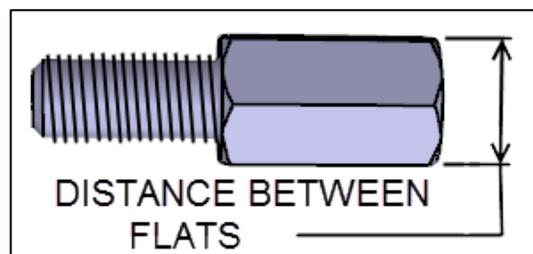
Figure 4

4. Inspect the distance between flats on the stud adapter. There are only two possibilities; 1/2" or 5/8".
5. First, use a 1/2" open wrench and check if you can engage the wrench between the flats of the stud. If you cannot engage the 1/2" open wrench on the stud, try a 5/8" open wrench and check if you can engage this second wrench between the flats of the stud and if it fits tight.

6. If the distance between flats is $5/8$ " , you have the correct stud. Move to step 7.

If the distance between flats is $1/2$ " , you have the wrong stud and you need to change it. Move to step 10.

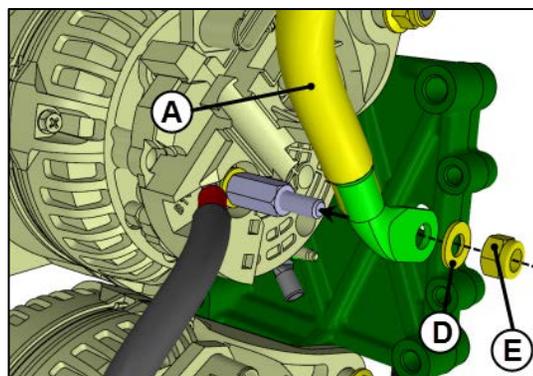
Figure 7

A : POWER CABLE

D: FLAT WASHER #5001341

E: LOCKNUT M8 #5001983 (*torque: 10 lbf-ft*)

7. Reinstall power cable **A**. To do so, connect power cable **A** to the stud adapter, install the flat washer **D** and the new locknut **E**.
8. **Protect the alternator stud and cable terminal against corrosion.** Apply anti-corrosion compound or **Color Guard Rubber Coating** on the stud adapter, the cable terminal, and the locknut.
9. Bulletin is complete.

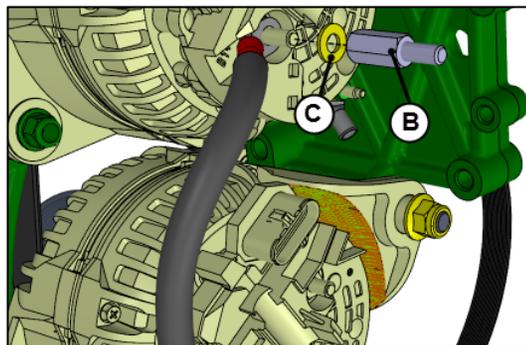
FIGURE 8

B : STUD ADAPTER #060297 (*torque: 10 lbf-ft*)

C: FLAT WASHER #5001341

10. Remove old stud adapter **B** (FIGURE 8).
11. Before installing the power cable, make sure that the nut that secures the alternator stud is properly tightened (FIGURE 9).
12. Install appropriate new stud adapter **B**. Make sure the jumper cable terminal and the flat washer **C** are still in place (FIGURE 8).

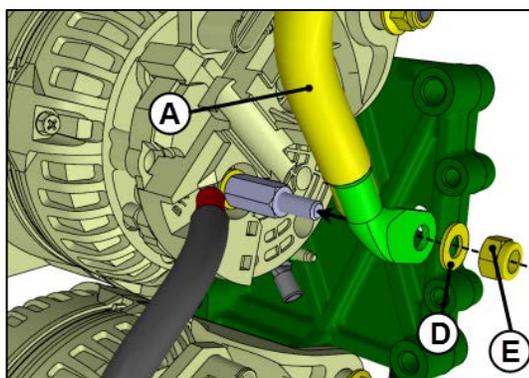
FIGURE 10

A : POWER CABLE

D: FLAT WASHER #5001341

E: LOCKNUT M8 #5001983 (*torque: 10 lbf-ft*)

13. Reinstall power cable **A**. To do so, connect power cable **A** to the stud adapter, install the flat washer **D** and the new locknut **E**.
14. **Protect the alternator stud against corrosion.** Apply anti-corrosion compound or **Color Guard Rubber Coating** on the stud adapter, the cable terminal and the locknut.
15. Bulletin is complete.
