PREVOST

WB18-01A

DATE :	January 2018	SECTION :	18 BODY
EXPIRATION:	January 2020		
SUBJECT :	PARCEL RACK DOORS REINFORCEMENT

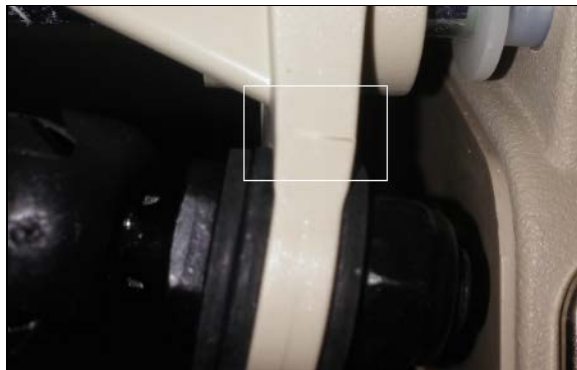
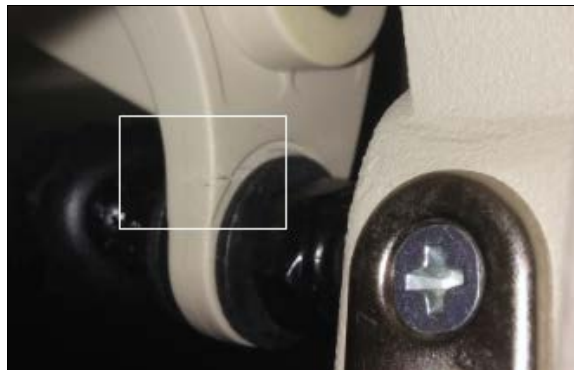
*Before proceeding with the steps below (reinforcement plates installation), the door support that holds the gas shock must be carefully inspected for cracks. If a crack is identified in the support, the door must be replaced. **DO NOT PROCEED** with the installation of the reinforcing plates on a cracked support.*

On the vehicles affected by this bulletin, it is necessary to add two metal reinforcement plates to all the parcel rack door supports that are holding a door gas shock.
