PREVOST

WARRANTY BULLETIN

WB17-16A

DATE :	February 2018	SECTION :	06 ELECTRICAL
EXPIRATION:	February 2020		
SUBJECT :	C15 & C58 CONNECTOR BYPASS

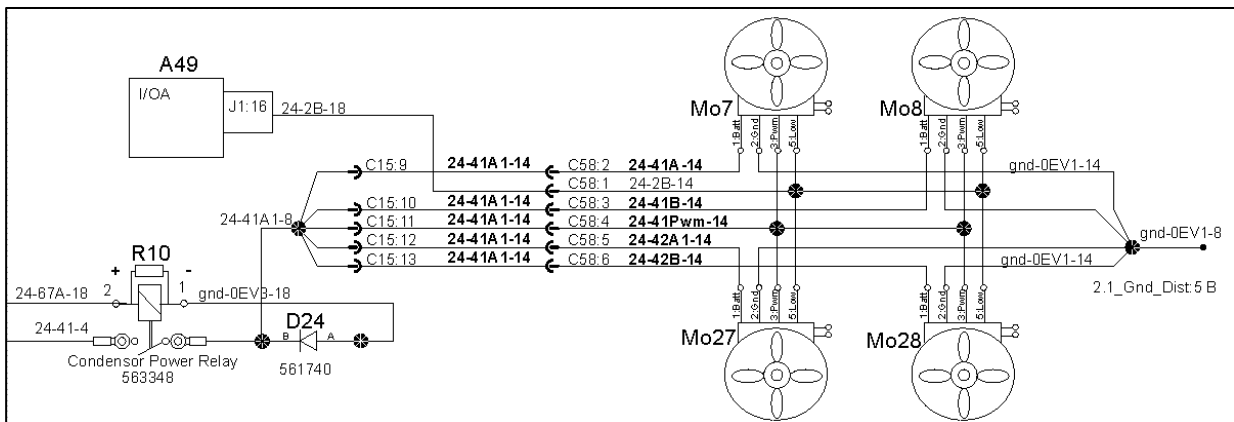
Figure 10 : ELECTRICAL DIAGRAM

On the vehicles affected by this bulletin, remove selected wires from C15 and C58 of the HVAC system wiring, and place them in new connectors C15B and C58B. New connectors have a higher amp rating.

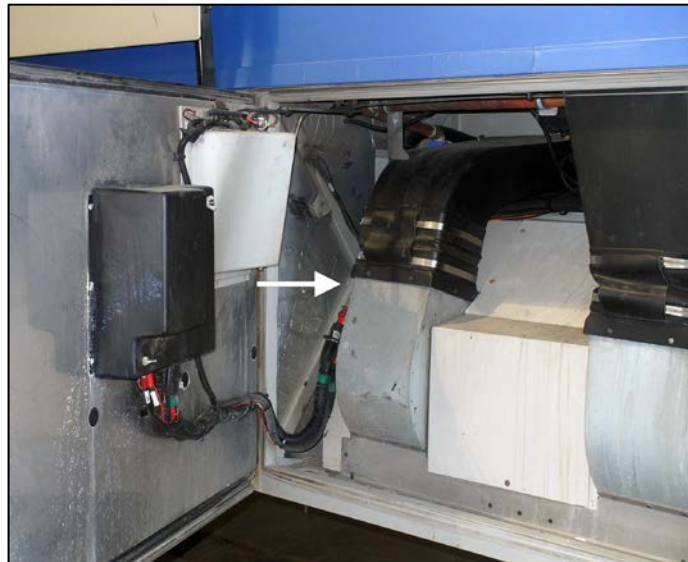
Figure 13: C15 General Location

A1. Locate connector C15 in the evaporator compartment.

A2. Harness and connector is attached along the left side of the evaporator fan enclosure.(Figure 13)

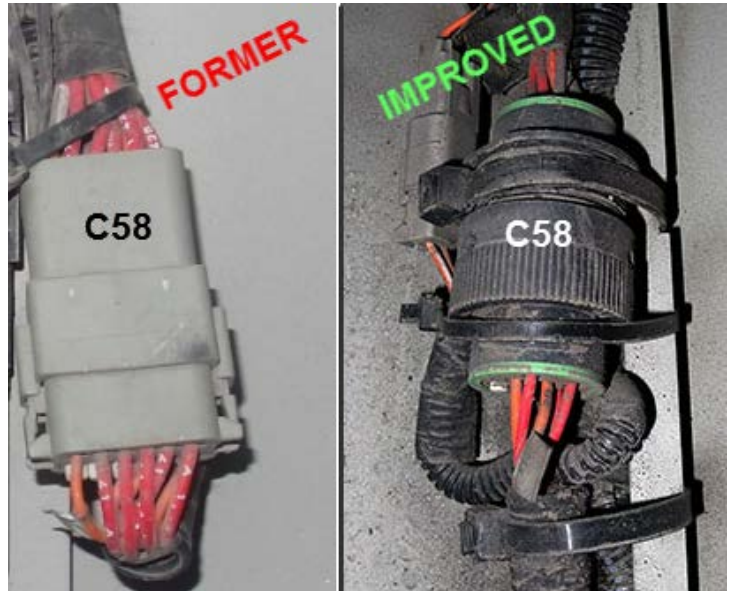
Figure 18 : C58 ARRANGEMENT "FORMER" AND "IMPROVED"

Visually confirm an *improved round Deutsch HDP20 series* connector (Figure 18) is already installed in this location.

This confirms the improvement is already implemented on this vehicle.

If the *former* connector is present alone, proceed to part "B", disregarding vehicle number.

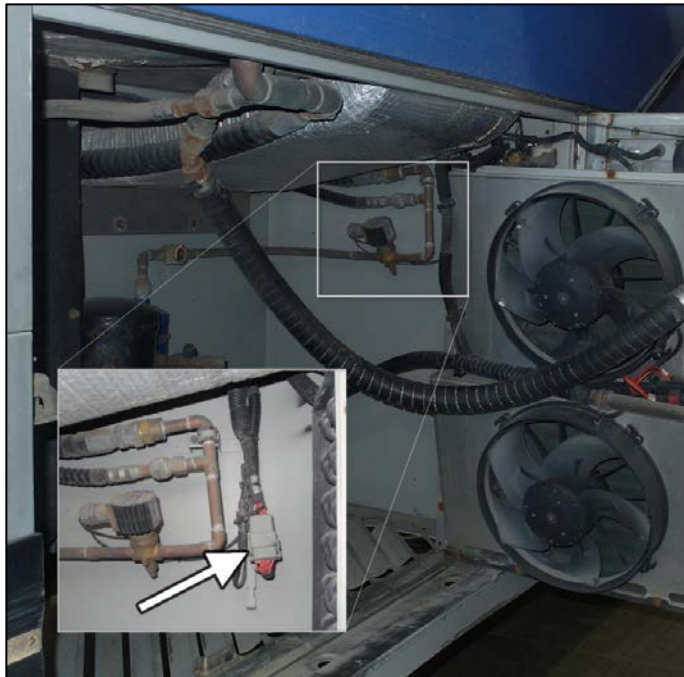
Figure 19: C58 location

B1. Locate connector C58 in the condenser compartment.

B2. Harness is located along the top of the right (front) wall of the condenser compartment. (Figure 19,Figure 20)

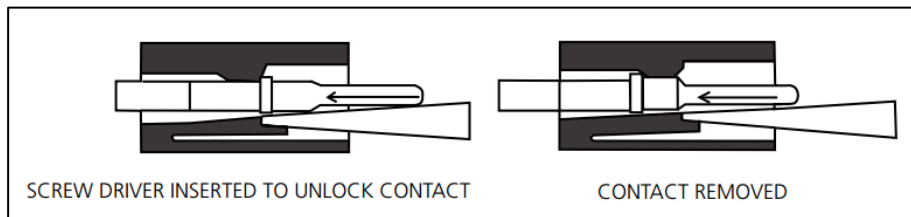
Figure 22: Terminal removal (Image: Deutsch)

B5. Inspect C58 connector for heat damage. Replace connector and pins if required

B4. Connector pair **C58**: Remove wires from the following cavities on each mating connector.
(Figure 22)

B6. On each wire, remove terminals, strip and crimp new terminals **N10273** pin / **N10274** socket.
