**SAFETY
RECALL**

SR19-04A

DATE :	June 2019	SECTION :	14 STEERING
SUBJECT:	DRAG LINK REPLACEMENT

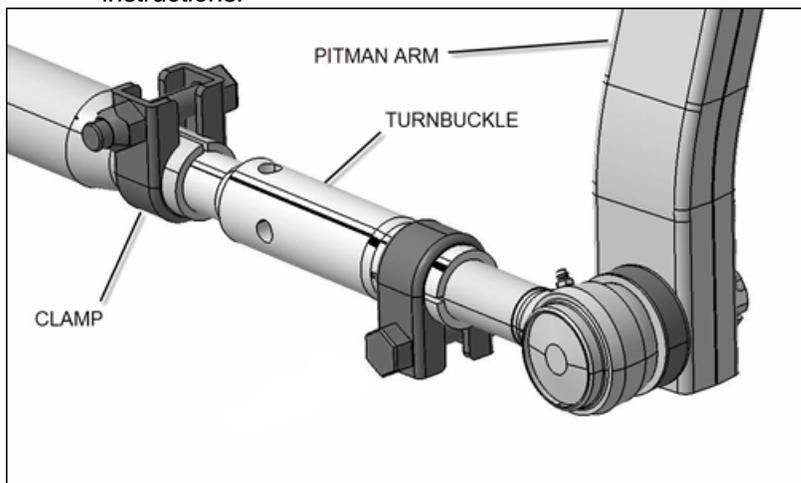
On the vehicles involved equipped with I-beam axles, cracks can occur and propagate in the steering draglink turnbuckle under certain conditions. If the cracks start to propagate, over time it may extend inward to a point where the turnbuckle may fracture.

If the turnbuckle fractures, a complete loss of steering would occur that can increase the risk of a vehicle crash or other risks associated with a disabled vehicle.

Figure 1: Recalled draglink with turnbuckle and two clamps.

Inspect the draglink and if required, replace the complete draglink by an improved part.

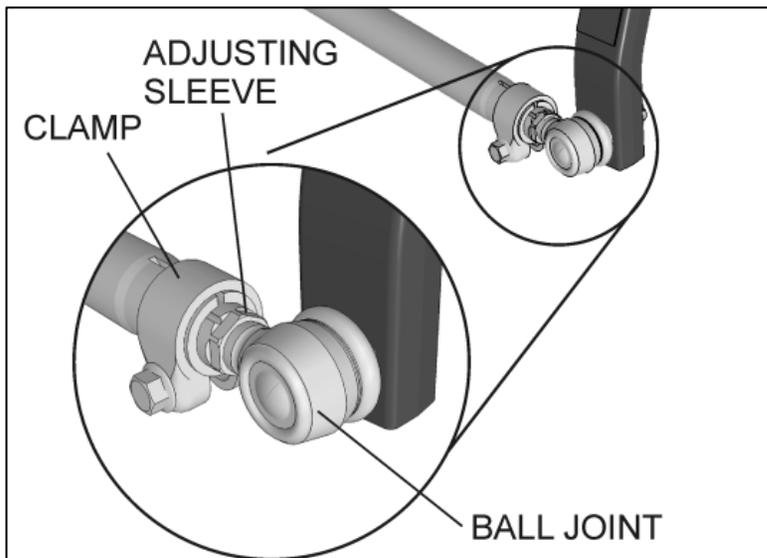
The improvement can be confirmed by the presence of an *adjusting sleeve* and a *single clamp* in the section nearest to the pitman arm. (Figure 2)

Figure 2: Improved 660699 draglink

If the vehicle already has this draglink, this is the improved part being installed in the recall. *You do not have to perform the replacement.*

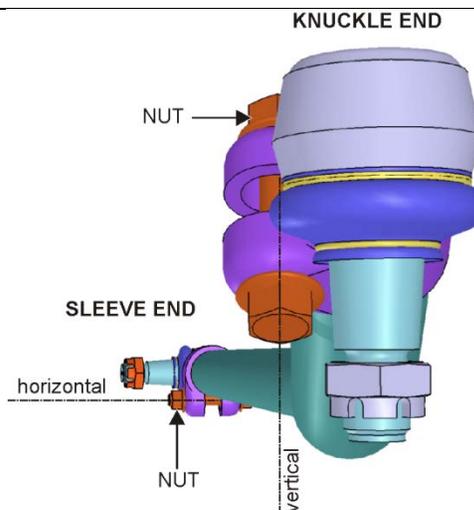
FIGURE 7: NOTE THE VERTICAL ORIENTATION OF THE CLAMP BOLT AT THE KNUCKLE END AND ON WHICH SIDE THE NUT MUST BE POSITIONED

10. To prevent interference between the ball joint clamp bolts and other components of the steering system, the clamp bolt must be positioned vertically as shown on FIGURE 7. **Tighten the clamp nut to 118-133 lbf-ft.**

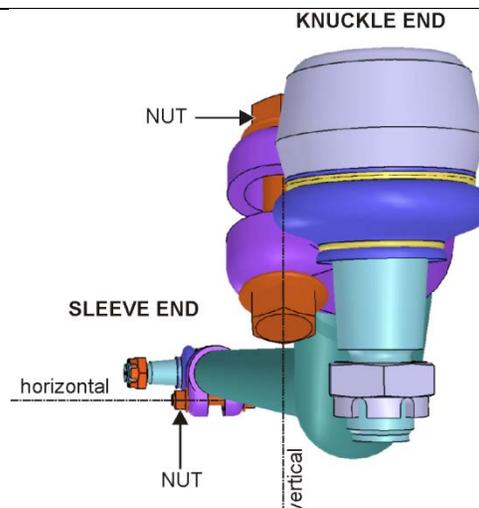
FIGURE 12: NOTE THE HORIZONTAL ORIENTATION OF THE CLAMP BOLT AT THE SLEEVE END AND ON WHICH SIDE THE NUT MUST BE POSITIONED

13. Adjust sleeve to the values of FIGURE 11.
14. Once the proper length adjustment is done, tighten the front end ball joint clamp. To prevent interference between the ball joint clamp bolts with other components of the steering system, the clamp bolt must be positioned horizontally as shown in FIGURE 12. **Tighten the clamp nut to 118-133 lbf-ft.**
15. Apply a torque seal mark
