PREVOST

WARRANTY BULLETIN

WB19-08

DATE :	October 2019	SECTION :	23 ACCESSORIES
EXPIRATION:	October 2021		
SUBJECT :	WCL CLOSED DOOR SIGNAL MISSING

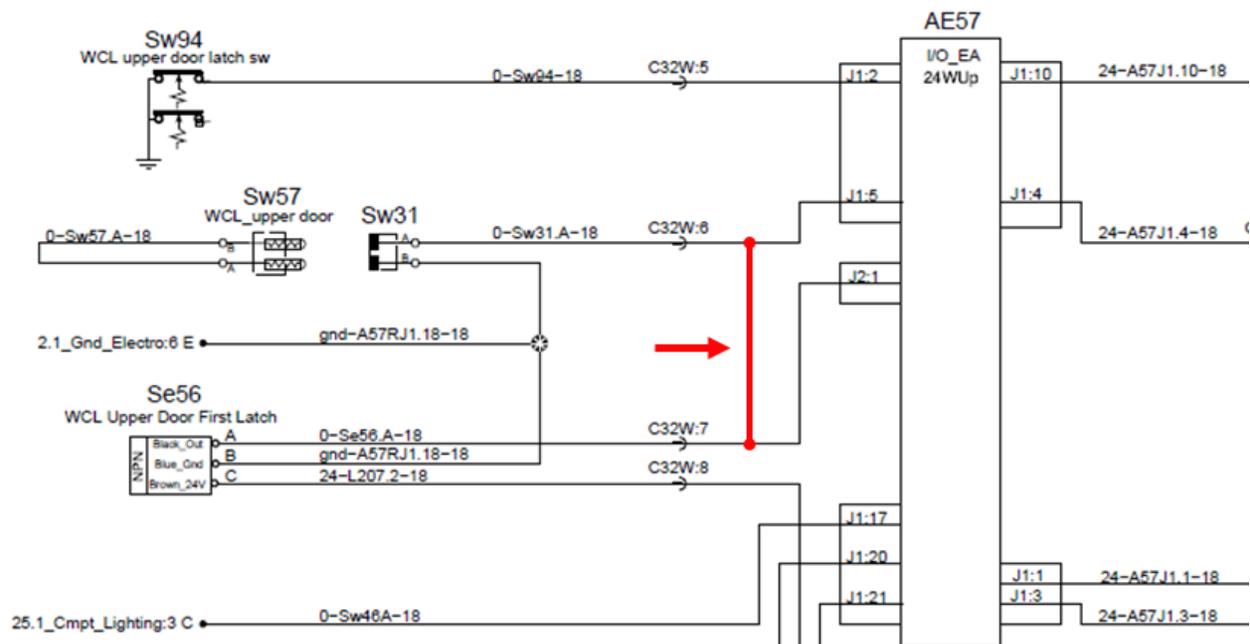
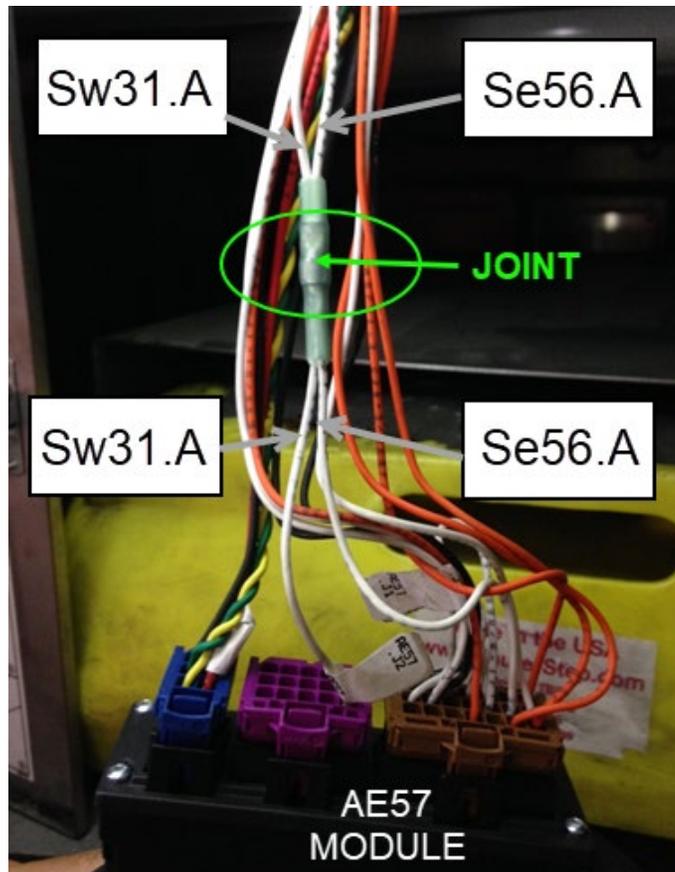
On the vehicles affected by this bulletin, the WCL (Wheel Chair Lift) may not go above or below intermediate position when the upper door is closed.

1. Locate the AE57 module in the luggage compartment (above WCL cassette).
2. Locate wires Sw31.A and Se56.A coming out of the module.
3. Cut both wires and splice the ends (all four wire ends).
4. Joint (solder) the four spliced ends together using a **562228** butt splice (cover the connection with a length of **562499** shrink tubing).
5. Power the vehicle electrical circuit and check for proper operation.
