**PREVOST**

**WARRANTY BULLETIN**

**WB19-40**

| SUBJECT : | <b>AWNING WINDOW MOTOR REPLACEMENT</b> | | |

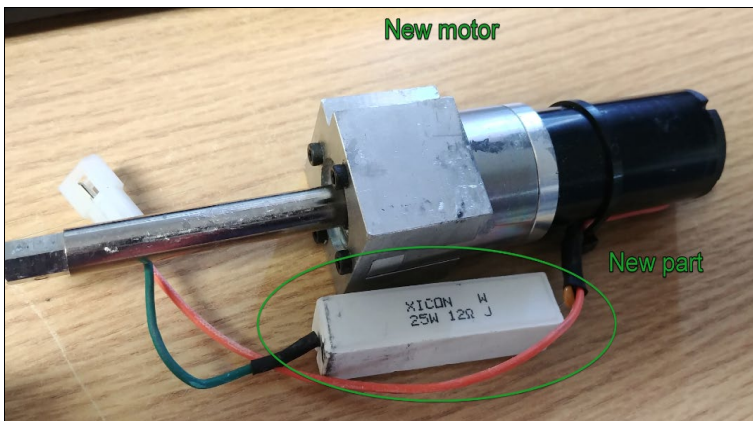
On the vehicles affected by this bulletin, the awning windows motors must be replaced by improved design units with inline ceramic resistors.
