### PREVOST

## SAFETY RECALL

**SR23-08**

SUBJECT: Emergency Exits - Release Mechanism Tension

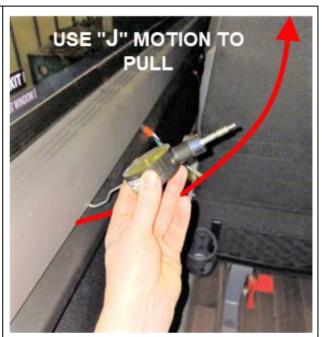
IMPORTANT : Use a « J » motion when pulling, do not pull straight at 45deg

- Install the tool hook in the middle of the window handle.
- Point the tool upward at a **45deg angle** (with the floor).
- <u>Slowly</u> pull with the tool until the handle unlatches (use a "J" motion, do not pull straight).
- Take this measurement twice to make sure readings are consistent. Take note of the average pull weight.
